AIR LEAKAGE: WHAT YOU SEE IS NOT WHAT YOU GET

March 10, 2016

Hannah Durschlag

Prepared for: Building Energy

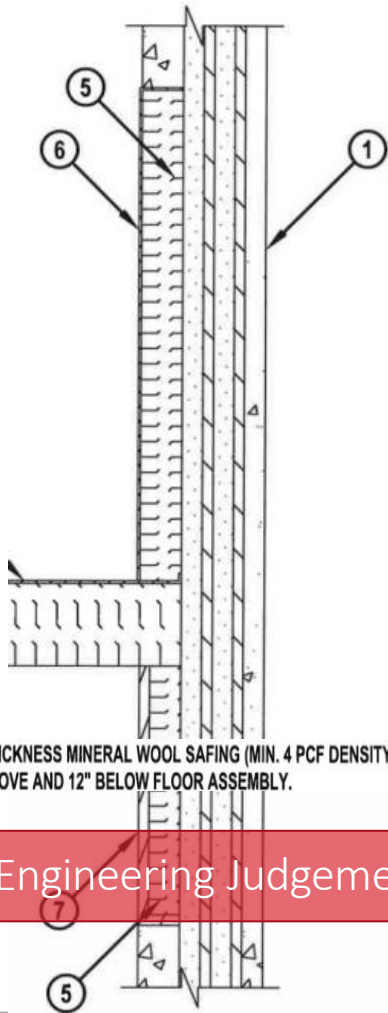
SMOKE SEAL AT PRECAST

What's wrong with this solution?

5. MINIMUM 1-1/2" THICKNESS MINERAL WOOL SAFFING (MIN. 4 PCF DENSITY) COMPRESSED 33%, EXTENDING 24" ABOVE AND 12" BELOW FLOOR ASSEMBLY.

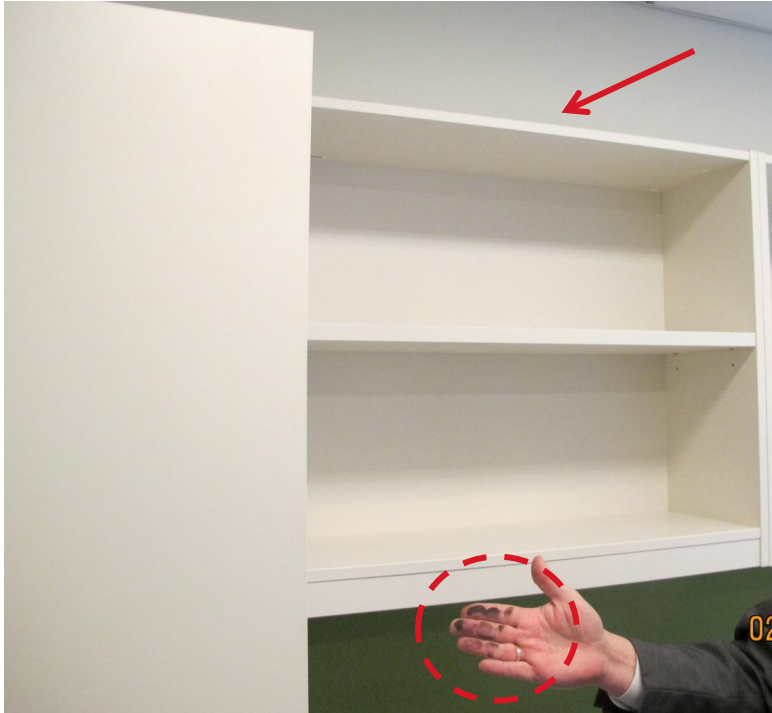
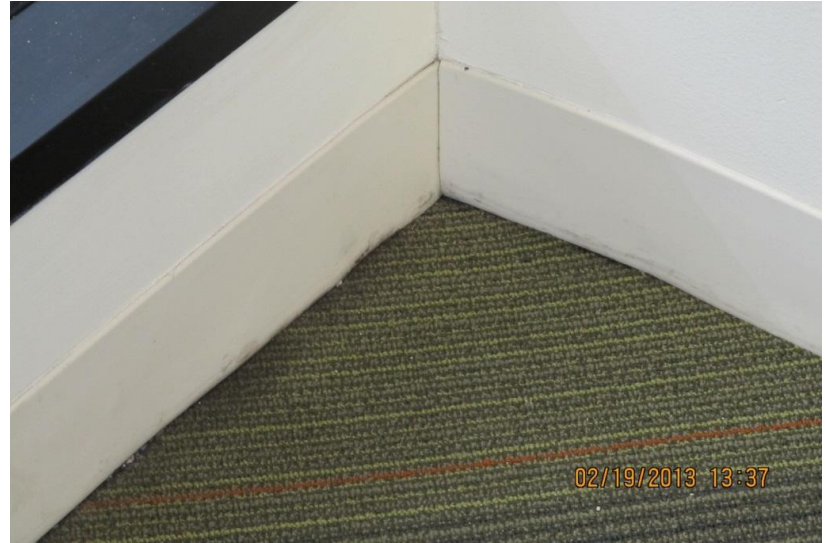
Two floors above the lobby

The Problem

We concluded that air from the T Station and garage was moving through the exterior granite pilasters into building. The dust and dirt in the air settled on surfaces inside the office spaces above.

Solution: Wire mesh to support spray foam insulation, followed by sprayed fibrous fire proofing.

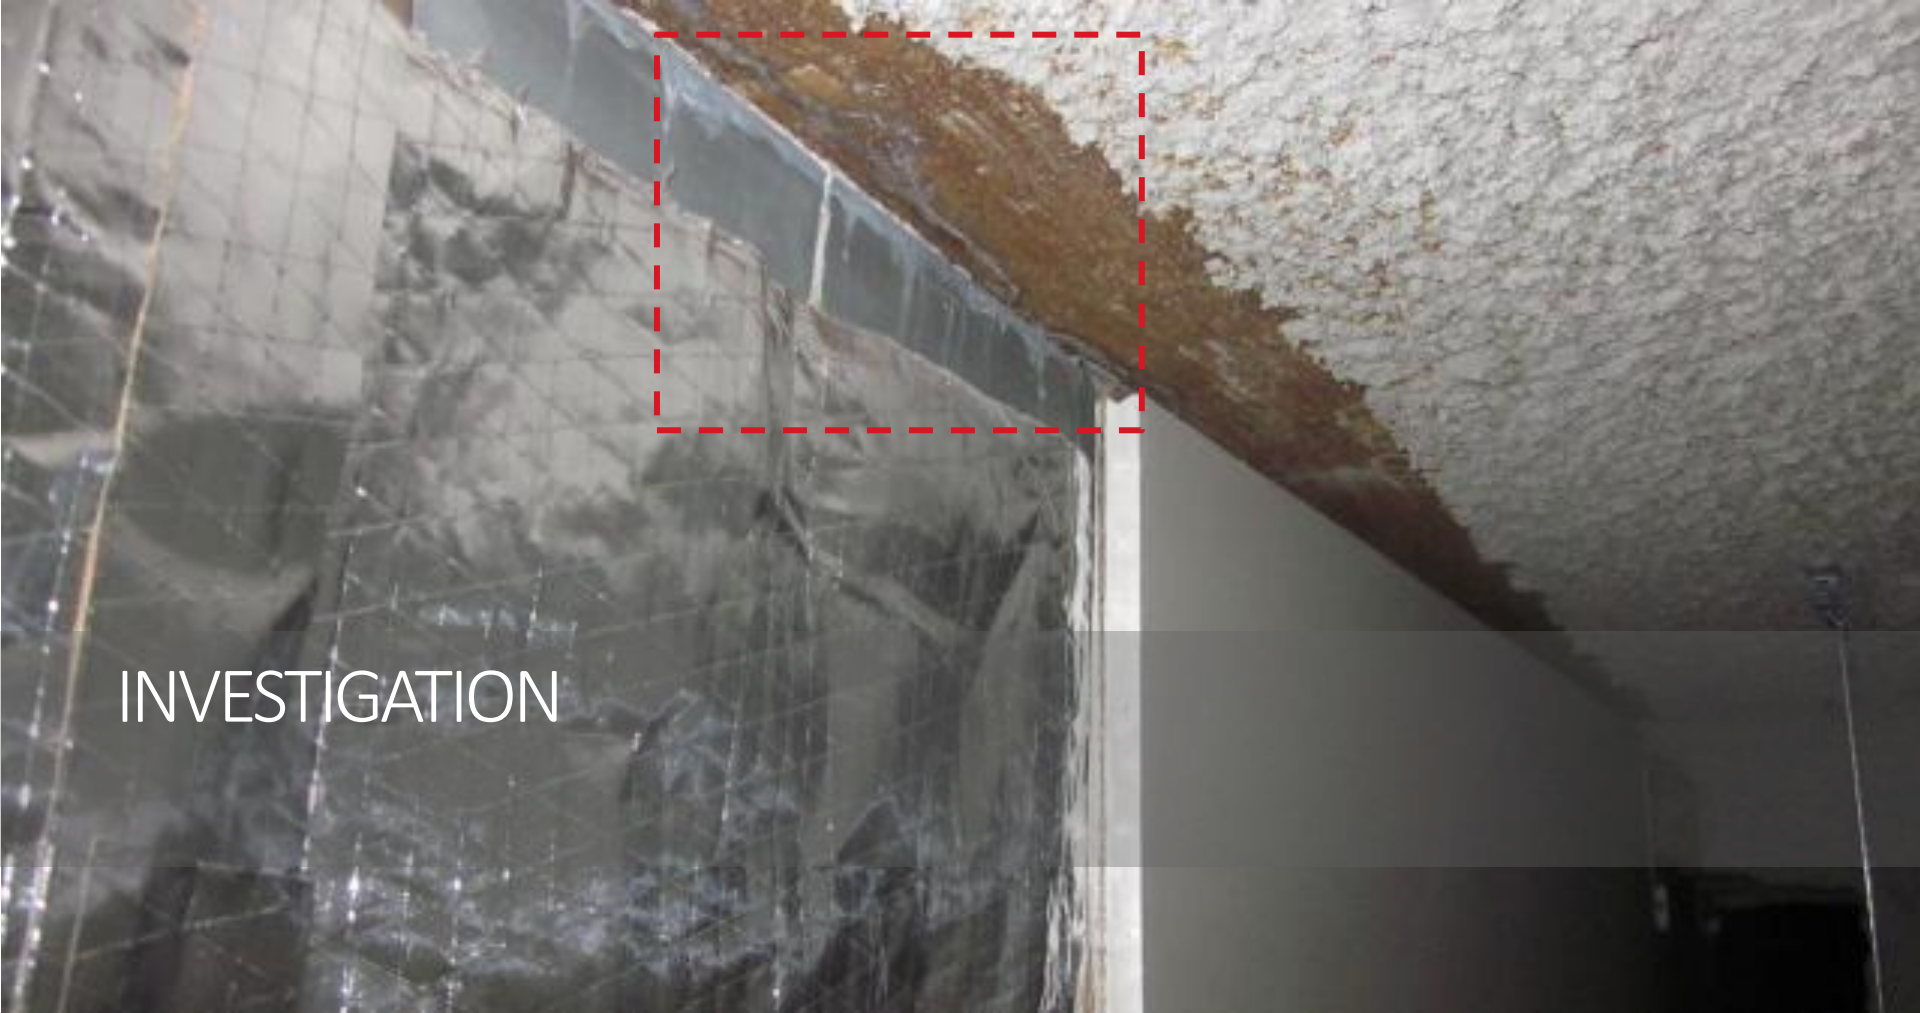
The Problem: Water was pouring in above the window heads.

This problem occurred on a relatively warm day with no rain fall, after a period of cold weather.

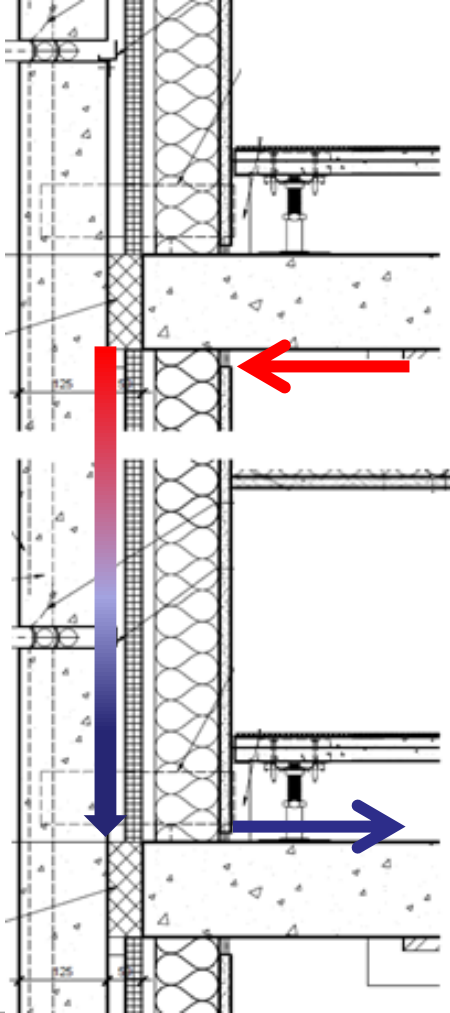
Exterior Wall

- Precast concrete, with double sealed joints
- 1" airspace
- 1" mineral wool
- 1" airspace
- Steel studs with foil faced fiberglass batt
- Gypsum wall board

Any thoughts? Where is the air barrier?

Note: humidified interior

- The GWB was not installed as an air barrier because the sealant was not installed
- The foil-facing was not installed as an air barrier
- Interior air formed a convective loop, and moisture was deposited on the back of the concrete
- This moisture froze, then melted when the exterior temperature rose
- The water ran across the window head and pooled under the raised floor

- Raise the temperature of the interior surface of the precast
- Eliminate movement of air flow laden with interior moisture into the wall cavity
- Align thermal, air, and vapor control layers
