Case Study # 1

Center for Parks and People

Energy Conservation Measures:

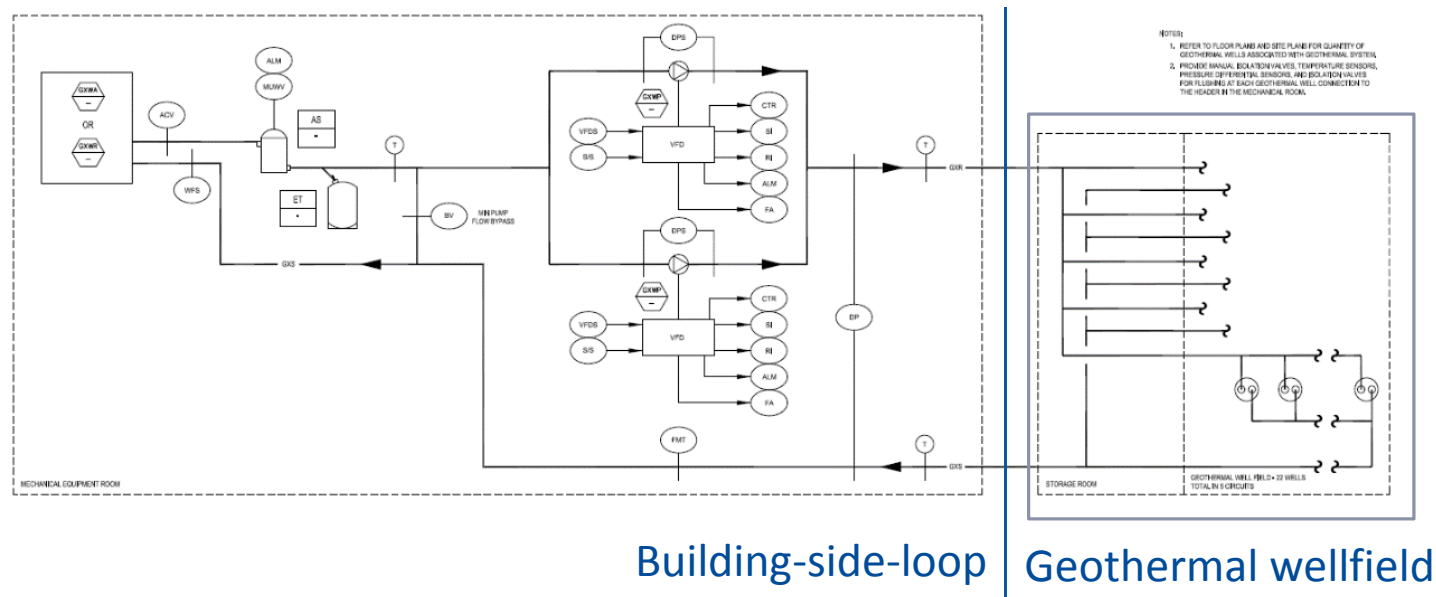
- Mechanical Highlights:
 - Geothermal VRF system
 - Natural ventilation backed up by mechanical energy recovery ventilation

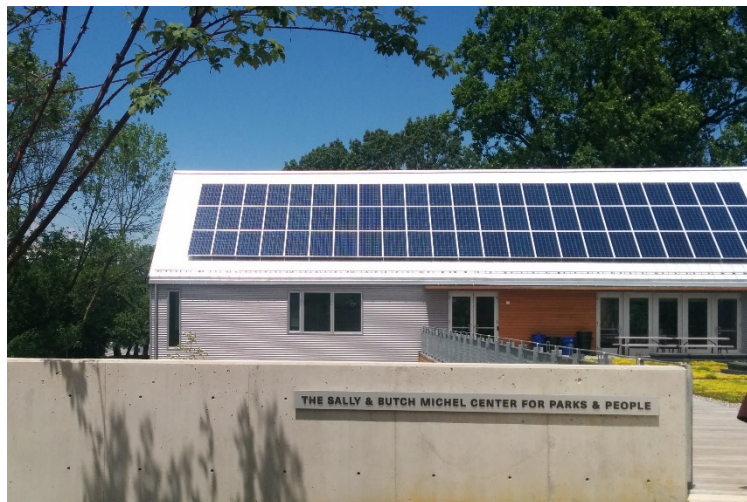
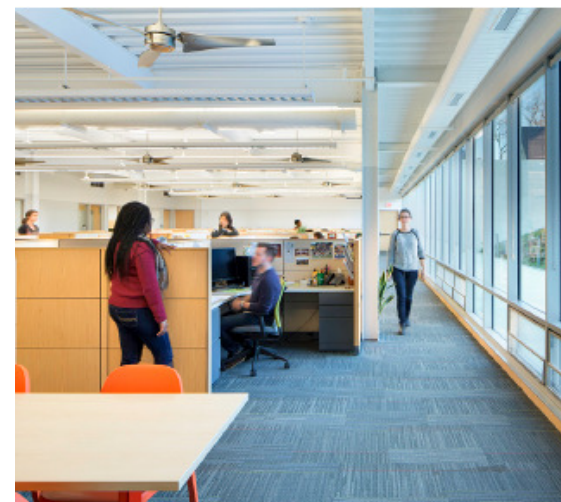
- Electrical Highlights:
 - PV array
 - CFL lighting
 - Daylight optimization

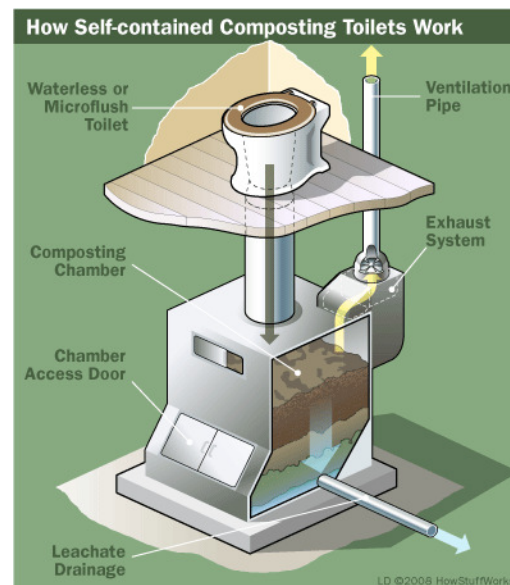
- Plumbing Highlights:
 - Low-flow fixtures
 - Composting toilets in the Superintendent's building

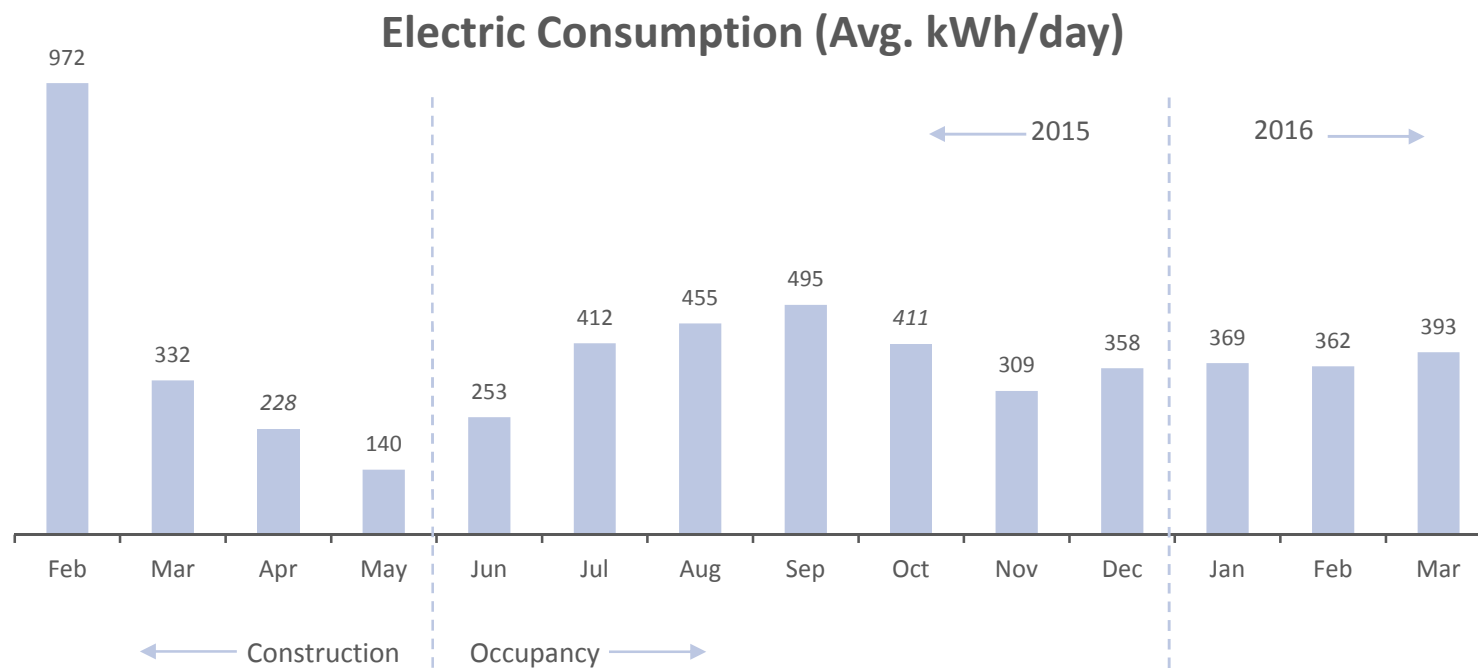
Post Occupancy Evaluation Utility Data Analysis:

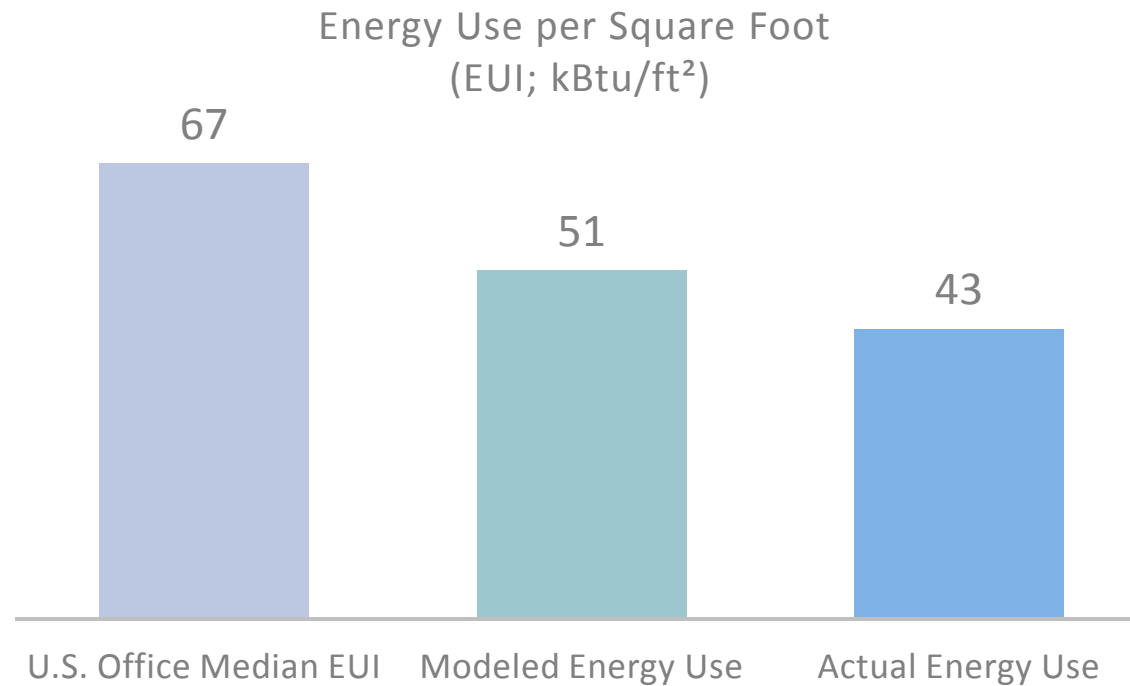
Post Occupancy Evaluation

Utility Data Analysis:
