New England's Favorite Roof Retrofit: Moisture Data from Three MA Case Studies

Brendan Kavanagh (Byggmeister Design Build)
Kohta Ueno (Building Science Corporation)

Northeast Sustainable Energy Association (NESEA)
March 29, 2023

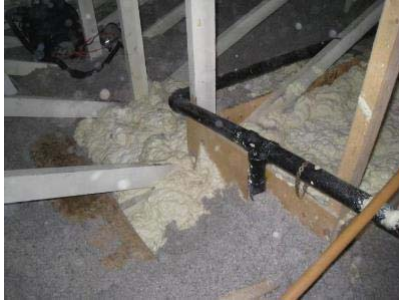
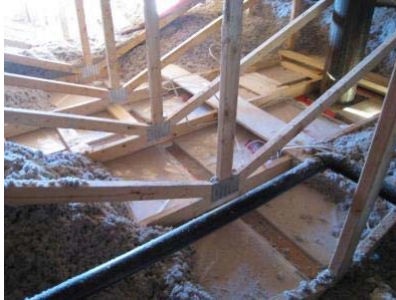
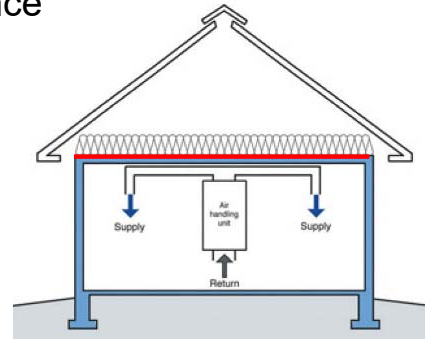
Ventilated Attics—Best Choice

- Roof sheathing dries to ventilated attic-moisture safe
- Interior moisture (air leaks) ventilated away in winter
- Air sealing at ceiling critical for best performance
 - (e.g., spray foam air barrier, detail with sealant)

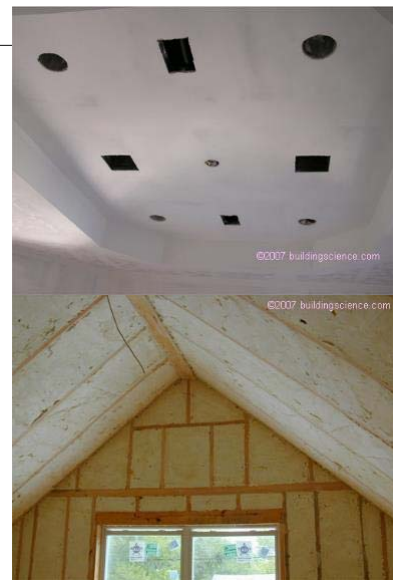
Then Why Unvented Roofs?

- Living space built into roof
- Vented cathedral assemblies—often poor performance
- Complicated rooflines, hip geometries—how to vent?
- Unworkable air barrier at ceiling line
- Blown-in rain (coastal)
- Hurricane tear-off
- HVAC in unconditioned attic—energy losses
 - Bring attic and ductwork into conditioned space

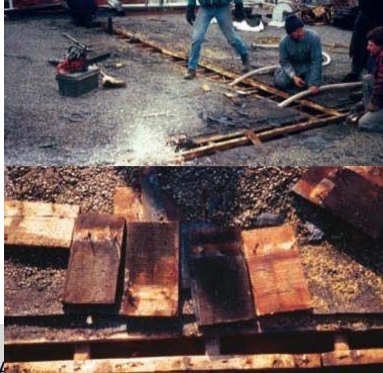
Fibrous Insulation Unvented Roofs

- Dense pack of unvented roofs common in cold-climate retrofits
 - Moisture risks (see BSI-043 “Don't Be Dense—Cellulose and Dense-Pack Insulation”)—2 in 10 failure?
 - Violates I-codes (see IRC § R806.4/R806.5)
 - “Ridge rot”—localized problems (SIPS same problem)

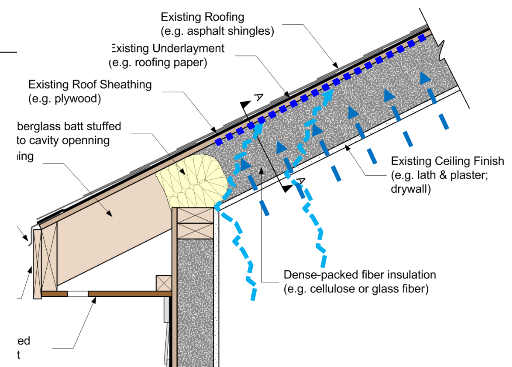
Why Unvented + Fibrous Risky?

- Different than walls?
- Moisture risks at sheathing
 - Interior-sourced air leakage
 - Vapor contributing too?
 - Zero-perm exterior (“wrong side perfect vapor barrier”)
 - Night sky radiation cooling
 - Stack effect in winter
 - “Ridge rot” (thermal and moisture buoyancy)

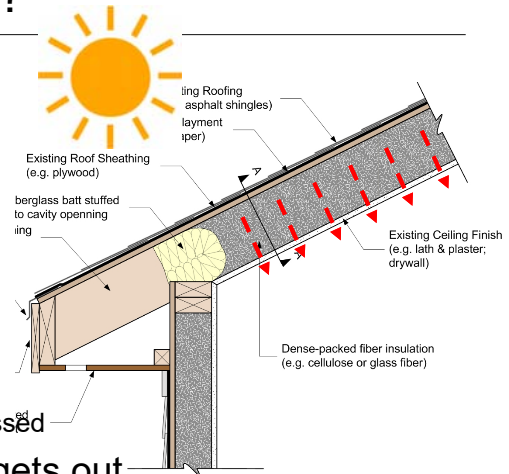
Why Unvented + Loose Fill Risky?

- Risk reduced by:
 - Airtightness of ceiling
 - Dense insulations that suppress airflow
 - Solar drive (north vs. south)
 - But white roofs, shading
 - Lower interior RH (winter)
 - Why many of them work?
 - Lower permeance interior
 - Need good airtightness—vapor retarder not bypassed
- Moisture accumulation: what gets in vs. gets out

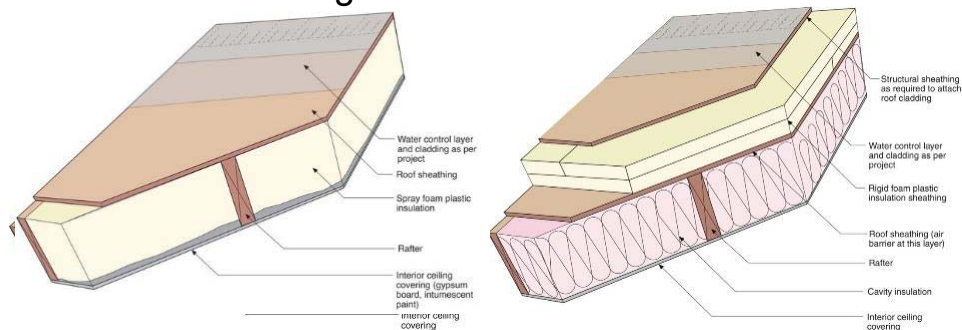
Spray Foam/Exterior Insulation Roofs

- 2006 IRC: R806.4 Unvented attic assemblies
- Minimum R-value of “air impermeable insulation”
 - Actually ratio of R-values (BSI-100 Hybrid Assemblies)
- Nail base needed with rigid foam on roof deck

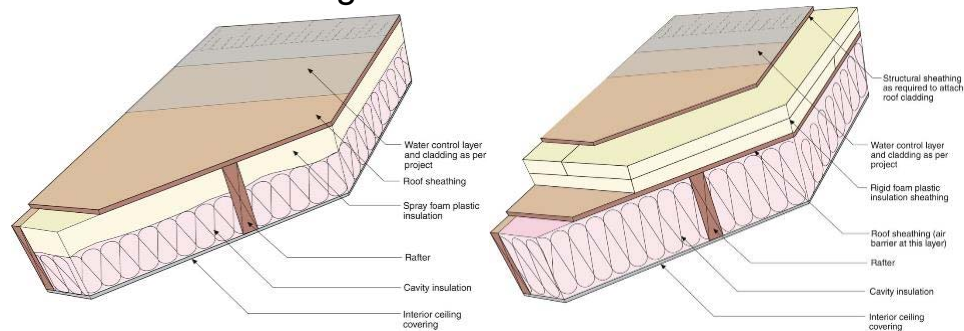
Spray Foam/Exterior Insulation Roofs

- 2006 IRC: R806.4 Unvented attic assemblies
- Minimum R-value of “air impermeable insulation”
 - Actually ratio of R-values (BSI-100 Hybrid Assemblies)
- Nail base needed with rigid foam on roof deck

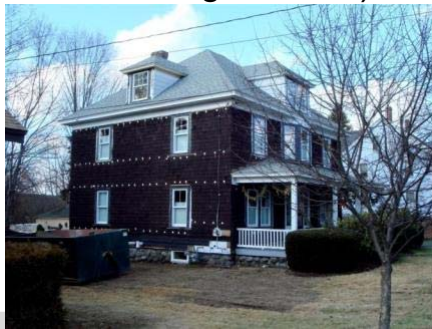
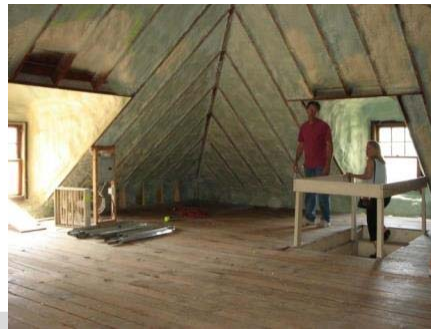
Why Fibrous Fill Unvented Roofs?

- Unvented roofs without spray/board foams could reduce costs and increase market penetration... IF moisture damage risks are addressed
- Retrofit opportunities (existing uninsulated living space at roof line, without demolishing finishes)

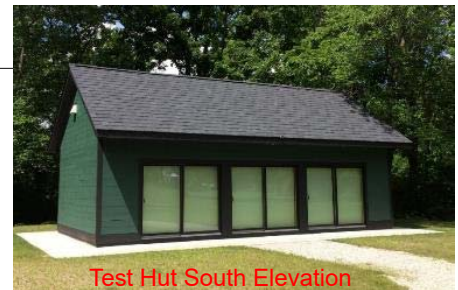
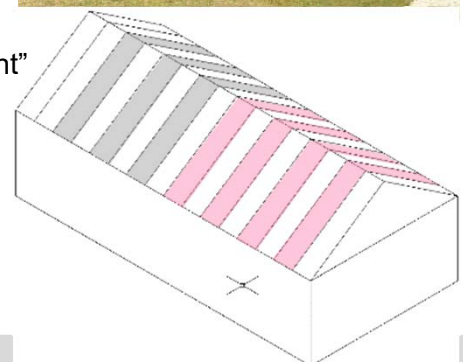
Test Hut Experimental Approach

- Climate Zone 5A test hut
- Eight north-south roof bays; guard bays
- $\pm R-50$ (14- $\frac{3}{4}$ " framing, 2012 IECC)
- Test variables (changed year-to-year):
 - Fiberglass vs. cellulose
 - Vapor retarder: variable vs. fixed perm
 - Diffusion vent at ridge: full size, none, "small," or "tight"
 - "Control" comparison § R806.4 spray foam + fibrous
- Varying interior boundary conditions
 - Winter 1: "Normal" interior conditions
 - Winter 2: Elevated RH (50% constant)
 - Winter 3: Air leakage into rafter bays

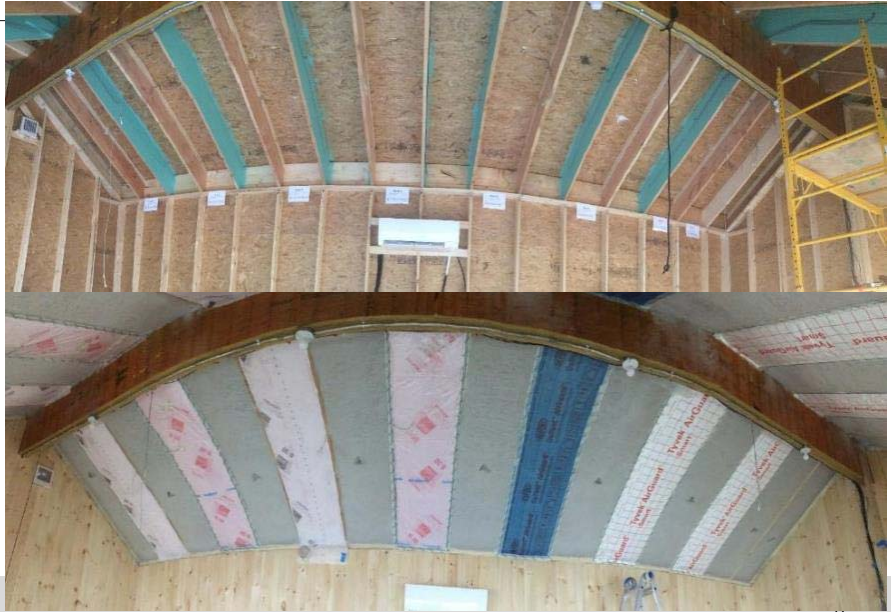
Test Hut Construction

- Test bays & guard bays alternate
- Cellulose & FG
- Various VBs
- Too much data to talk about here...

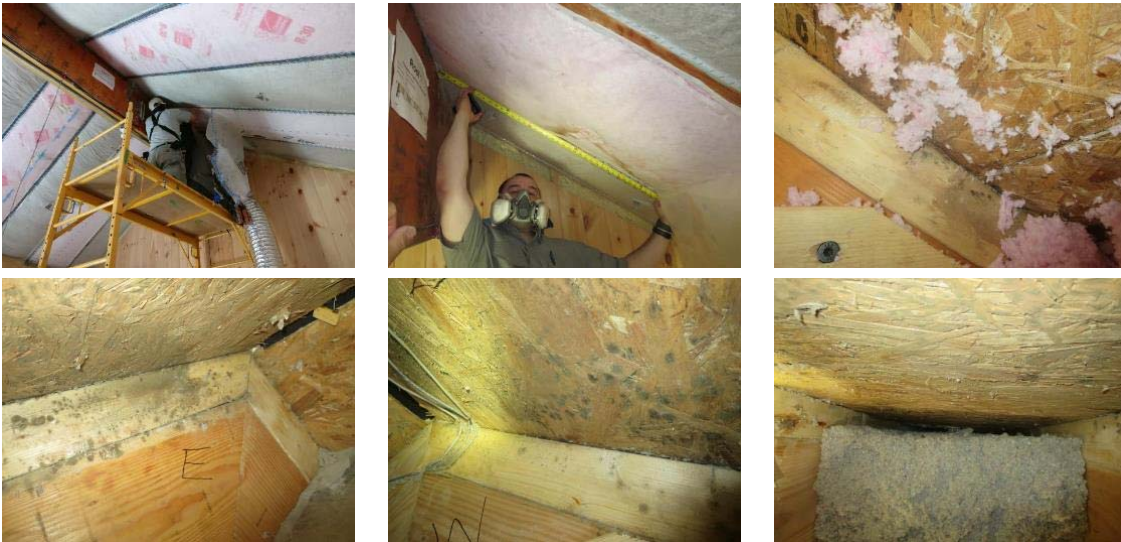
Summer 2 Disassembly Work: Found Some Mold

- Unvented fibrous insulation roofs **can** work, **BUT**
 - Ensure complete packing of insulation/density
 - Still vulnerable to small (0.5 CFM) air leaks
- Mold found after Winter 2, despite “calculated safe” (mold index < 3.0)
 - Vulnerability to moisture damage at ridge
- Difficult to recommend for widespread use and acceptance in codes
 - High indoor RHs more likely w. tighter construction and high occupant density/multifamily
- Retrofit solution for failing assemblies?
 - Demolition + spray foam not possible?
 - No place in code to allow

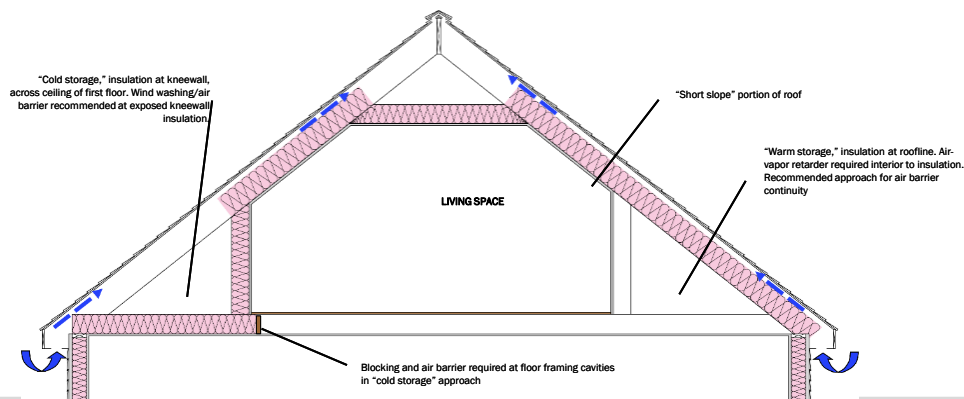
Story and a Half (Cape Cod Short Slope)

- Possible application to retrofitting “short slope” of kneewall attic geometry
- Eliminates “chute,” possible to retrofit longer runs

- Higher R-value in limited cavity
- Test hut: no problems low in roofs
- Not proven by BSC research, but this is “lower half of roof” geometry (low risk portion)
- Rafter bay has “full-size diffusion vent”
- Common practice in weatherization NE/Midwest

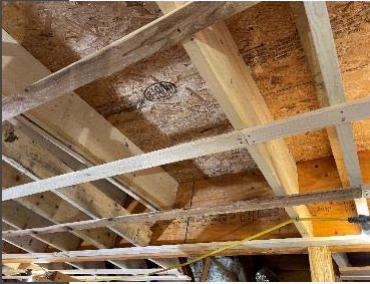
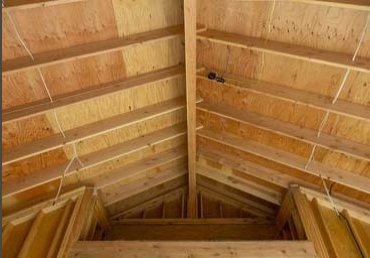
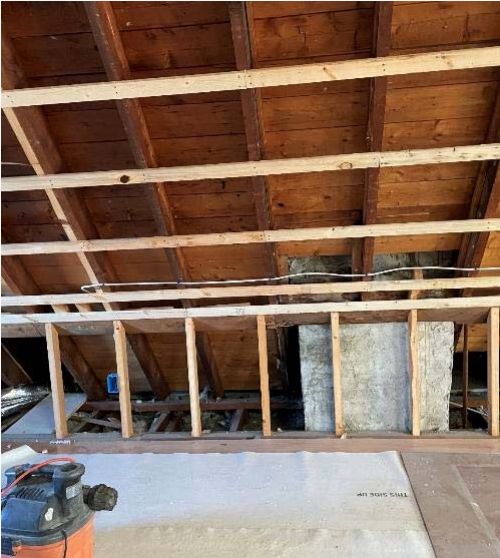
Roof sheathing

- OSB: Less resilient
- Plywood: OK
- Board: More resilient

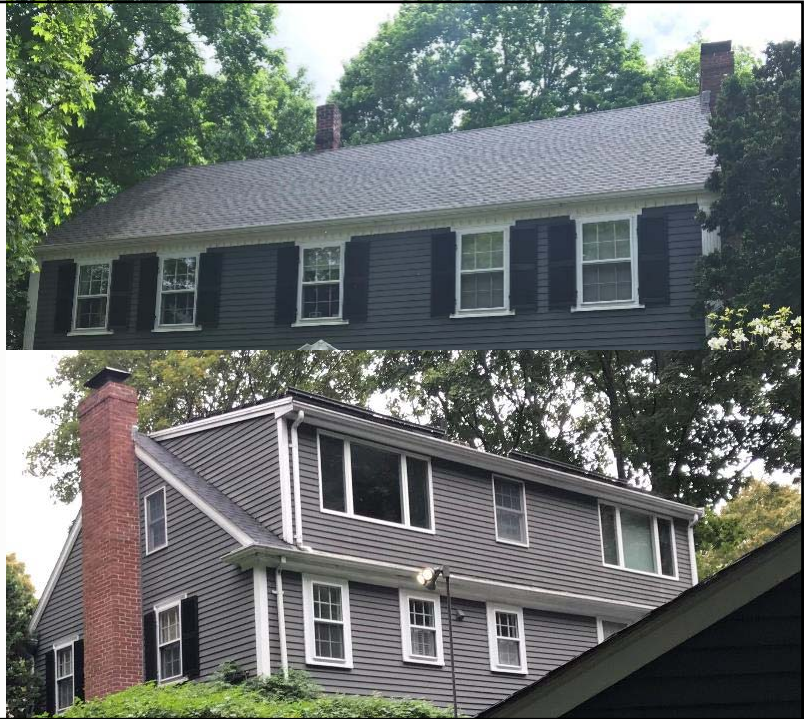
Pre-work Exterior Conditions

- No roof venting
- Front roof faces north, asphalt shingles, shading on the east side
- Chimney at center to be removed
- Rear roof faces south, large low slope shed dormer

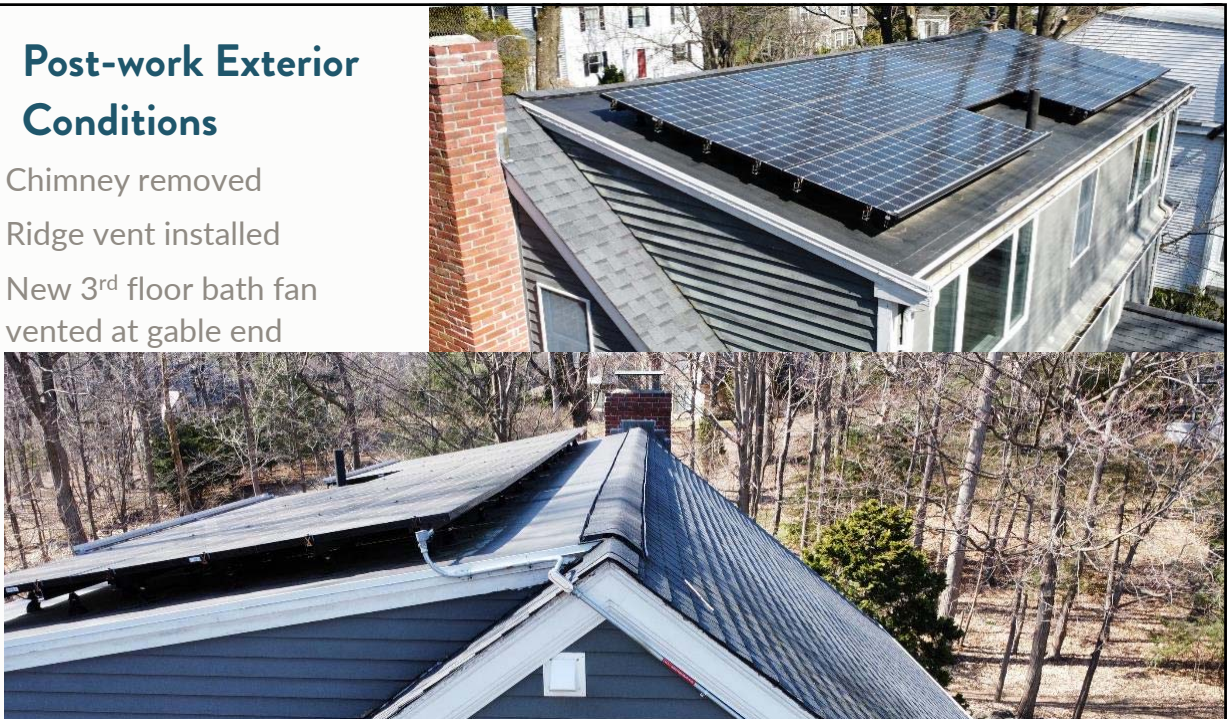
Post-work Exterior Conditions

- Chimney removed
- Ridge vent installed
- New 3rd floor bath fan vented at gable end

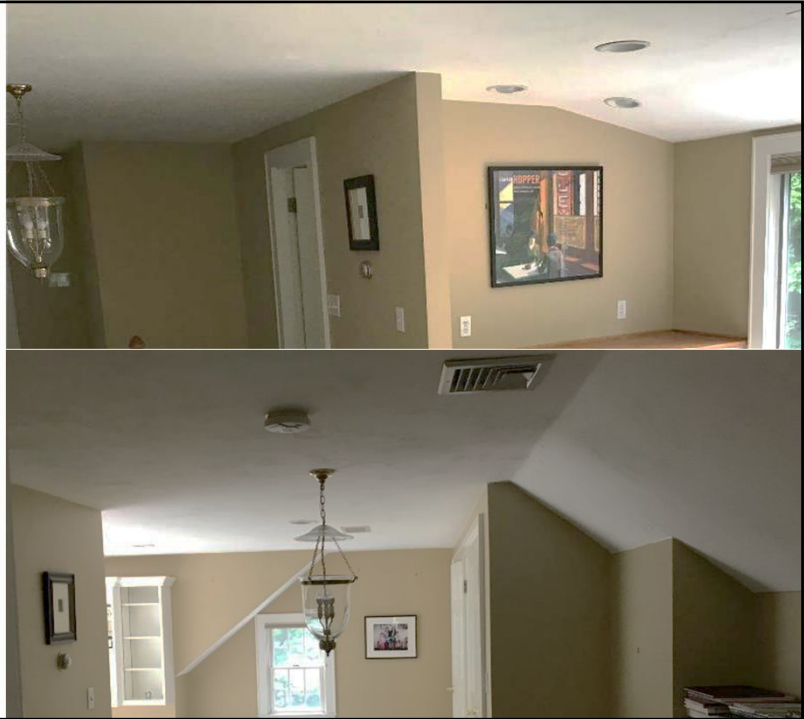
Pre-work Interior Conditions

- Small portion of finished low slope on south side shed dormer
- Flat ceiling across much of the middle
- Recessed lights and duct work introduce many air leakage points

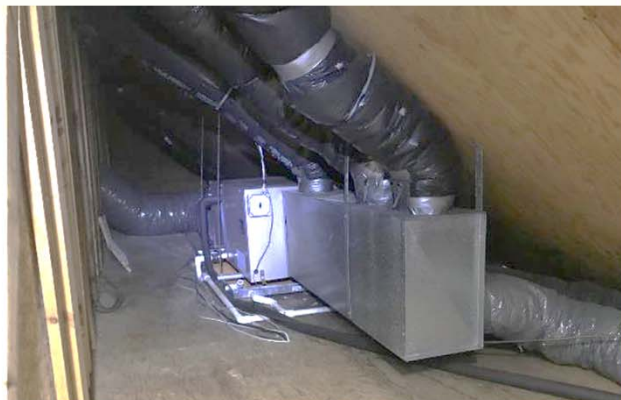
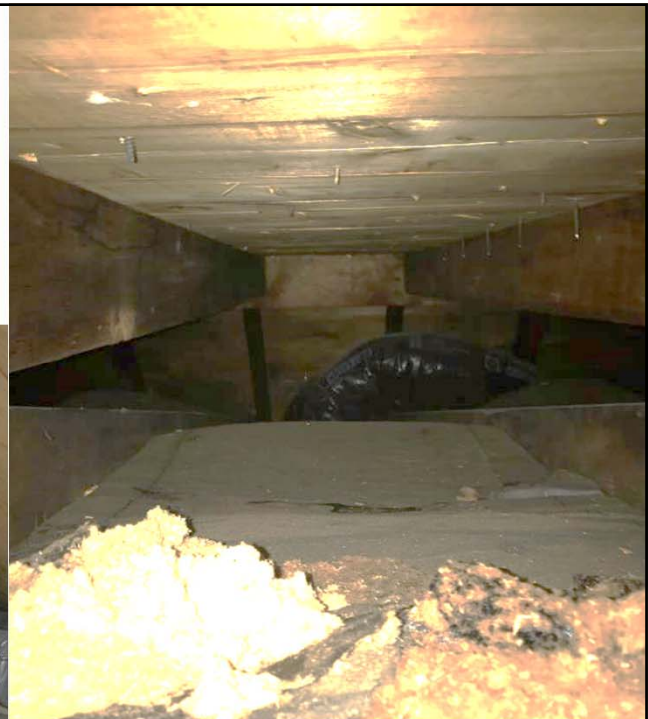
Pre-work Interior Conditions

- North side roof has steeper pitch with plywood sheathing above AC system
- All spaces have 1" batt insulation, air space, and board roof sheathing with no venting

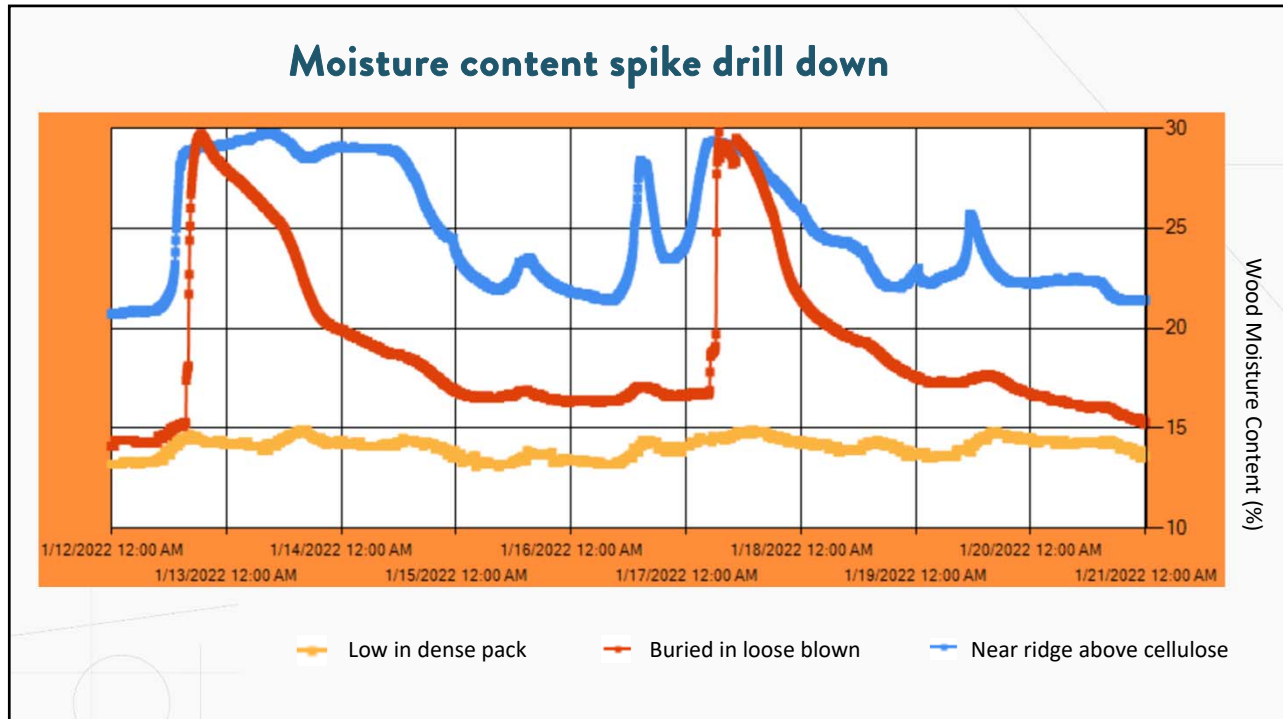
Moisture spikes near shower

- New recessed light in shower (air sealed)
- New bath fan just outside (also air sealed)
- Timer switch for bath fan

- Moisture accumulates near ridge as expected
- Solar panels and/or roof pitch can reduce solar drive
- We should be careful around humidity sources like showers

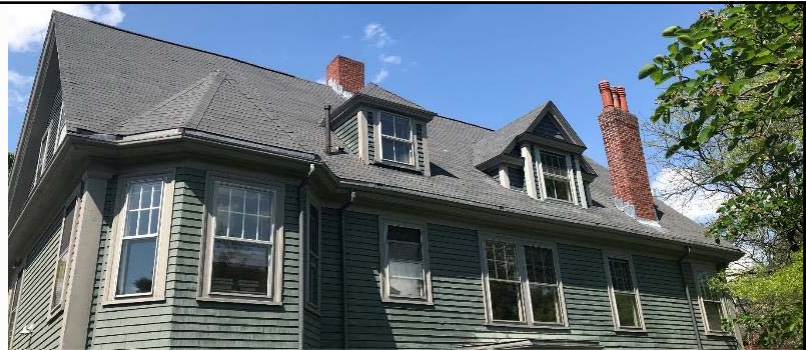
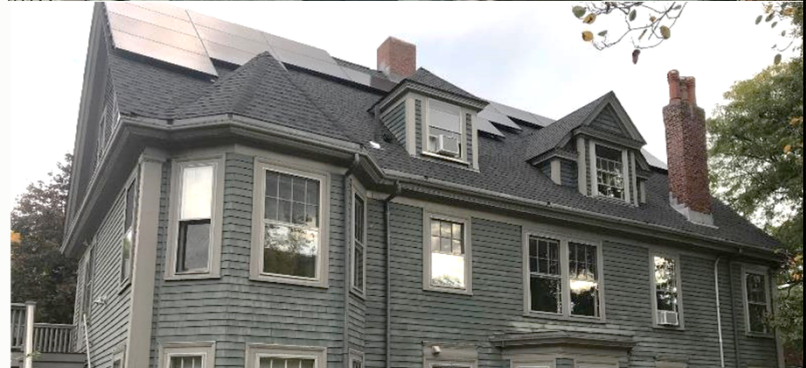
Pre-work Exterior Conditions

- Roofing, solar panels, and ridge venting installed just before
- Pre-existing soffit & gable vents
- Insulation in some areas, not others
- Dormers & bump outs added on, built over old roof system

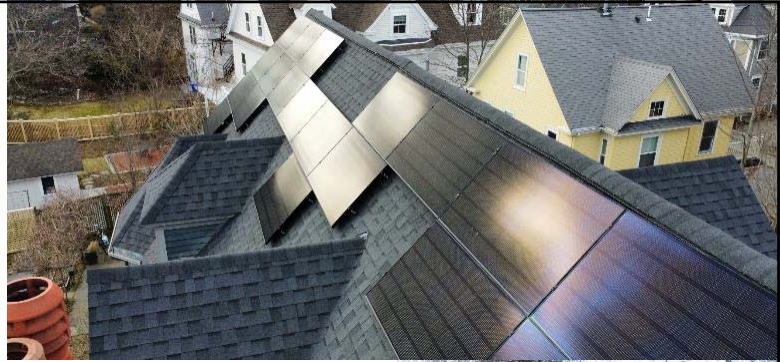
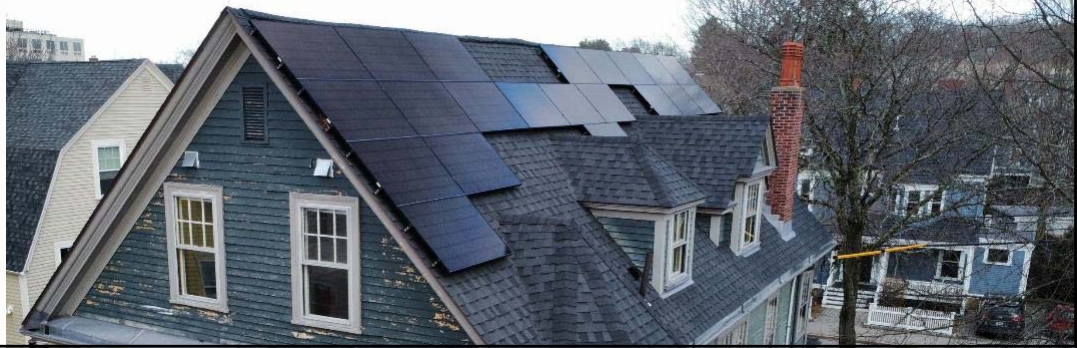
Post-work Exterior Conditions

- Chimney removed
- Ridge vent patched
- ERV installed & vented at rear gable end

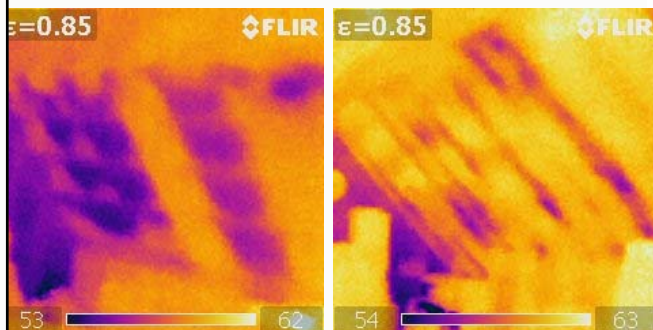
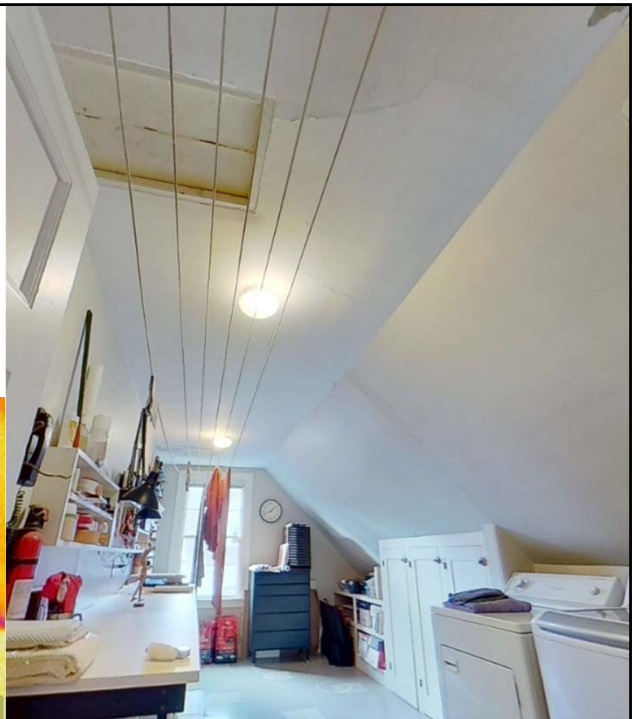
Pre-work Interior Conditions

- Small scuttle to access attic
- Variable insulation quality in finished slopes, none in walls
- No recessed lights or ducts

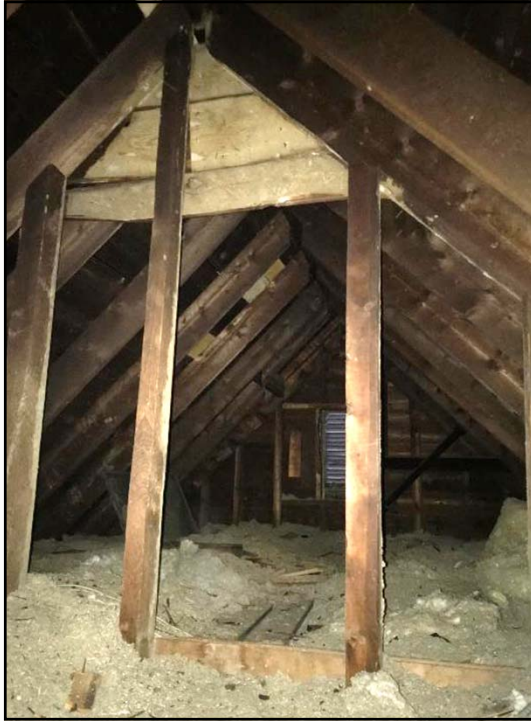
Pre-work Interior Conditions

- Board roof sheathing again
- No baffle venting installed in finished slopes
- Gable & ridge vents move a lot of air

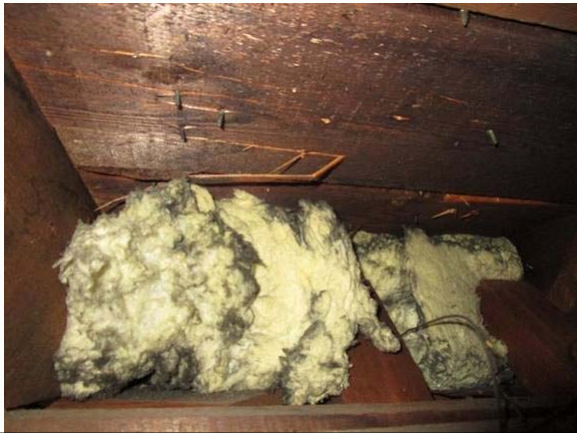
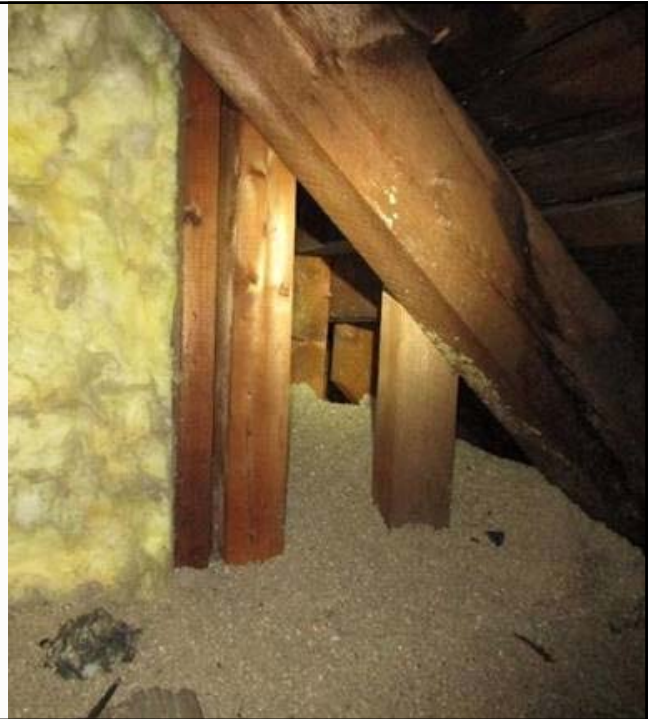
Pre-work Eave Conditions

- Fiberglass stuffed to dam slopes
- Open to walls, no air sealing

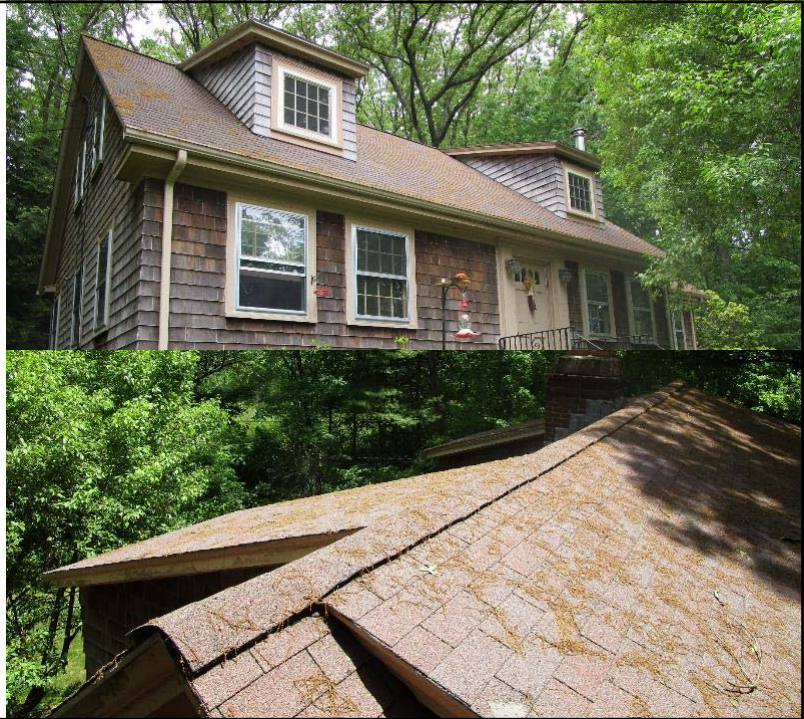
Pre-work Exterior Conditions

- Front faces North & slightly east
- Soffit vents in most areas are minimal small circular vents only
- Small ridge vent across both roof areas
- Gable vents on either side of main roof only

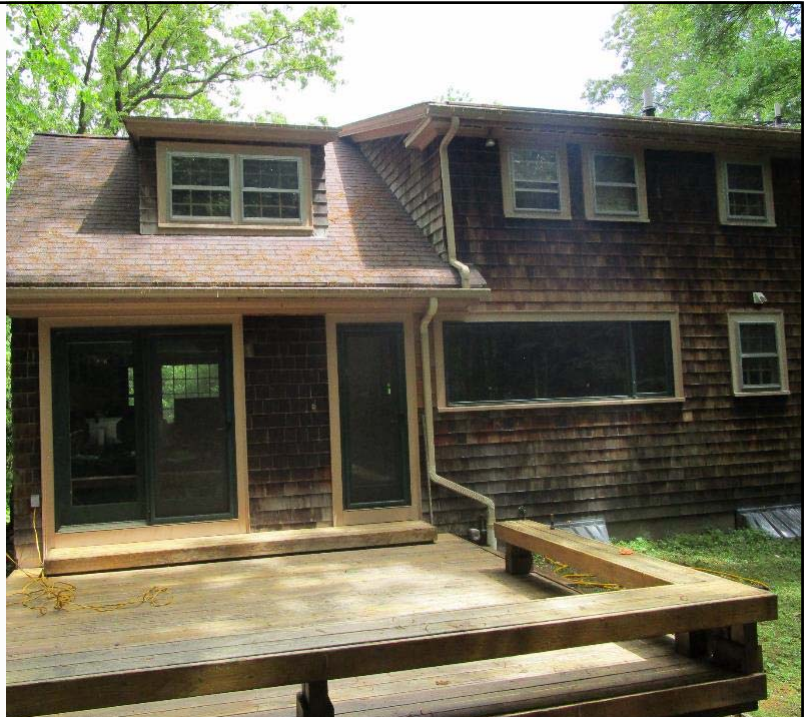
Pre-work Exterior Conditions

- Rear faces south & slightly west
- Low slope roof had larger soffit venting installed, didn't help
- Substantial shading from surrounding trees, however few pines so solar exposure in winter increases

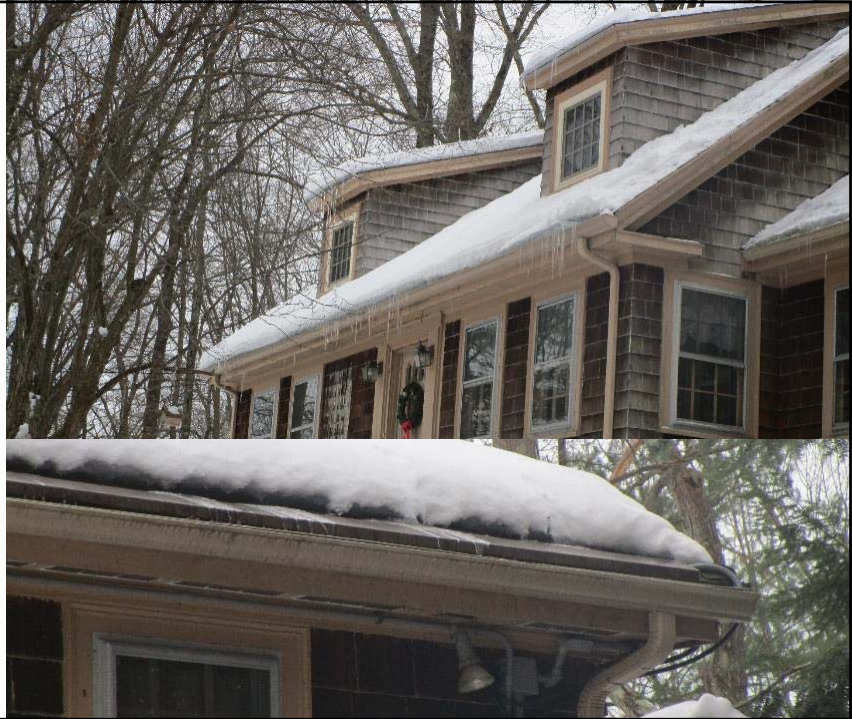
Pre-work Exterior Conditions

- Ice dams throughout
- Winter management difficult for aging homeowners
- Electric cable & panels installed at high roof after increased soffit venting didn't help

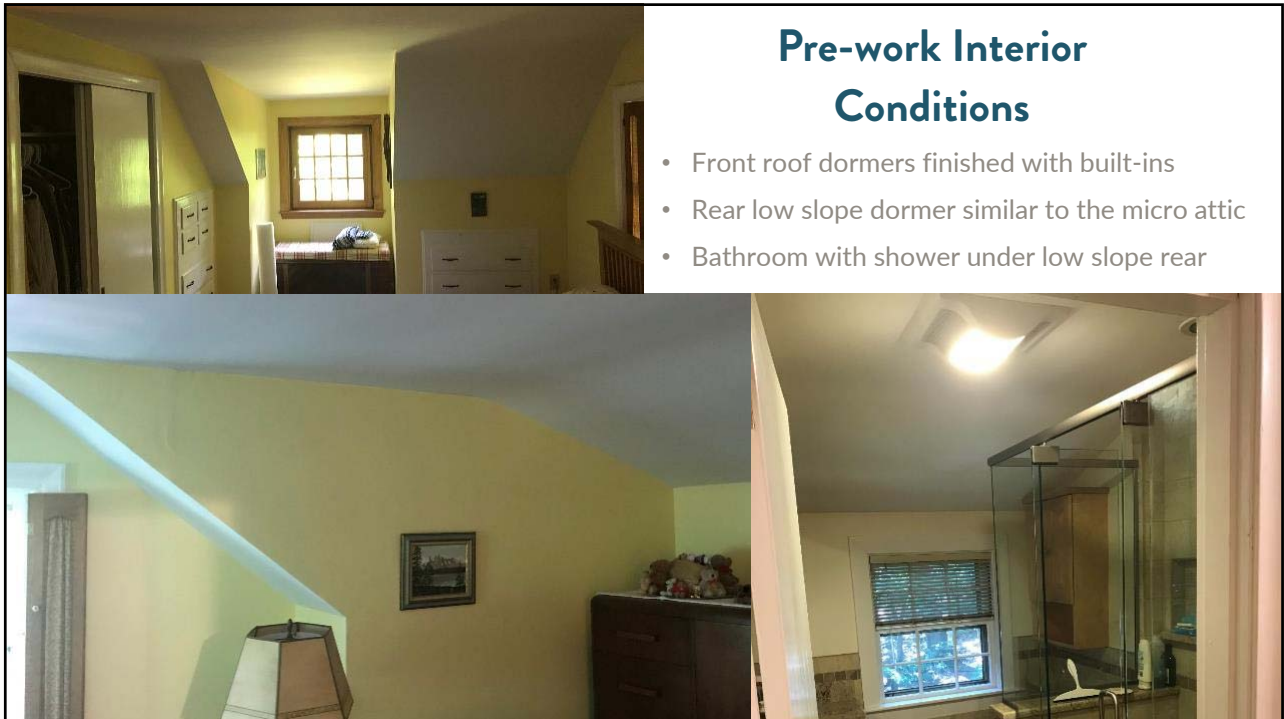
Pre-work Interior Conditions

- Front roof dormers finished with built-ins
- Rear low slope dormer similar to the micro attic
- Bathroom with shower under low slope rear

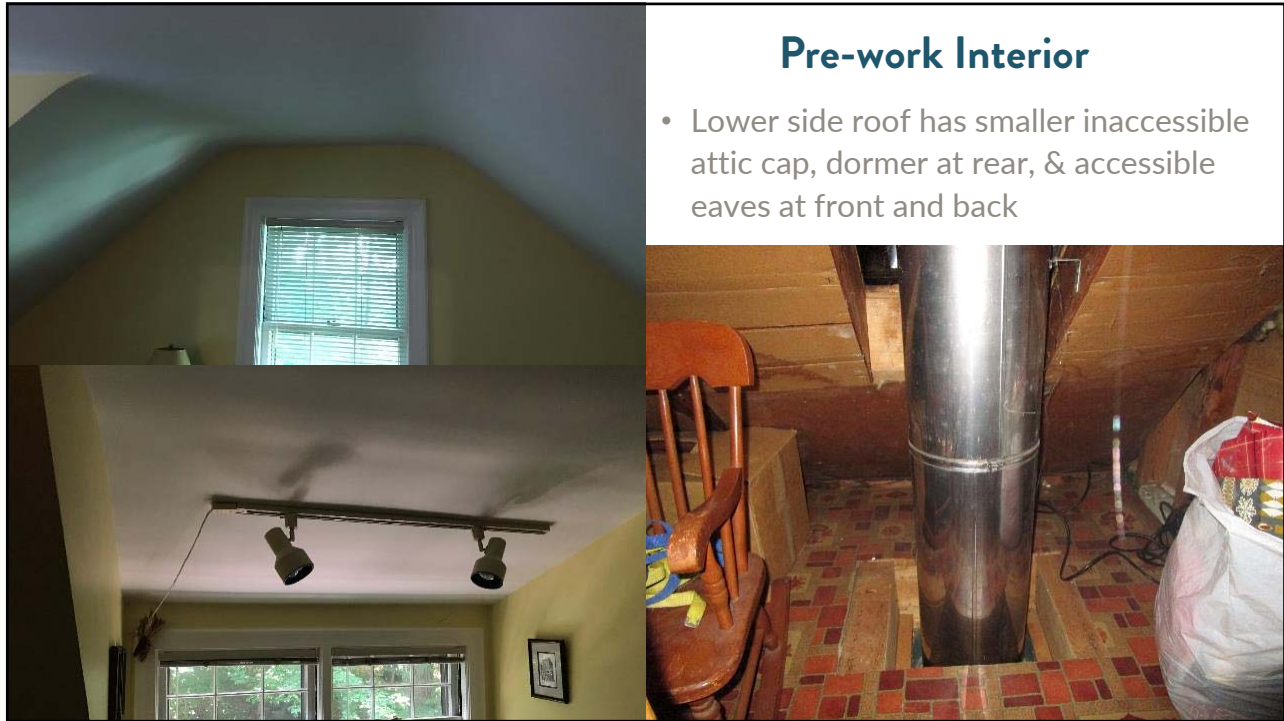
Pre-work Interior

- Lower side roof has smaller inaccessible attic cap, dormer at rear, & accessible eaves at front and back

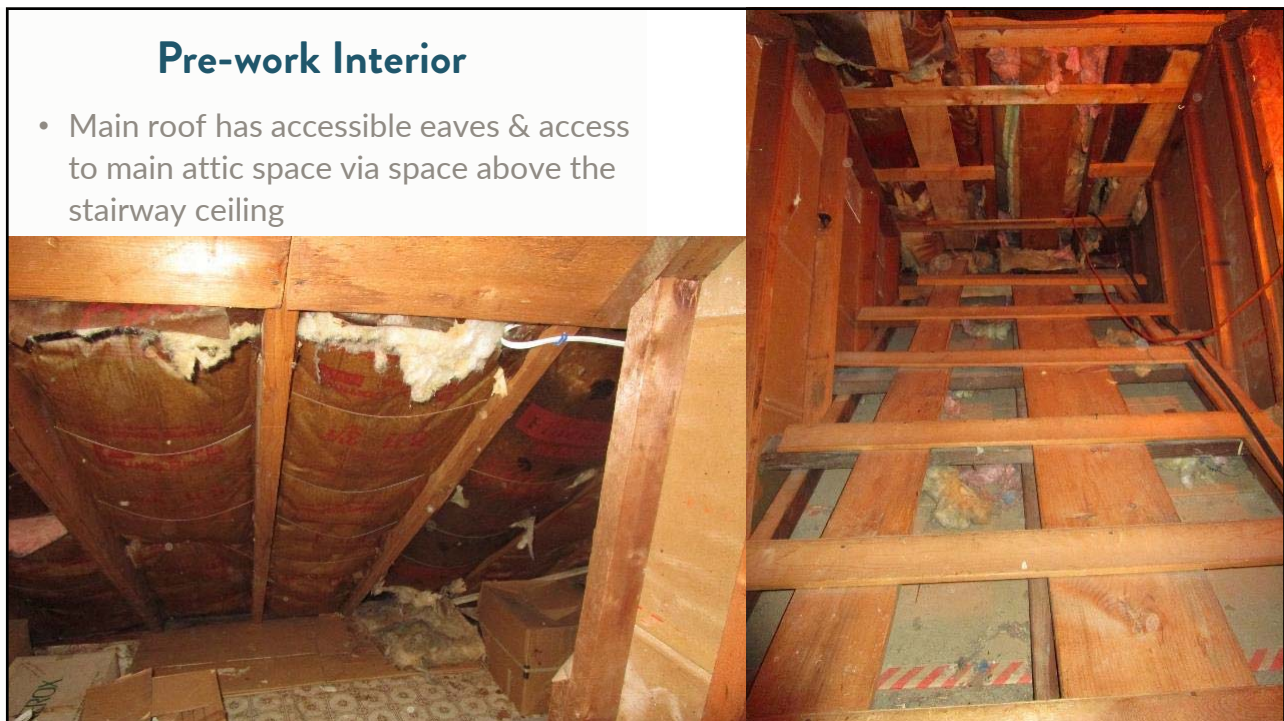
Pre-work Interior

- Main roof has accessible eaves & access to main attic space via space above the stairway ceiling

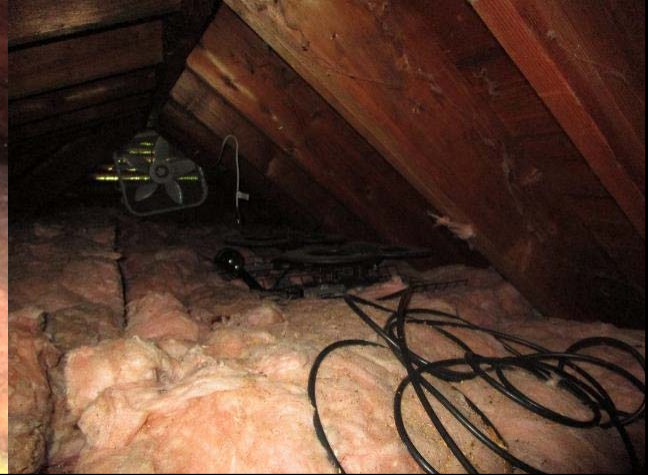
Pre-work Interior

- Main attic has gable vents and make shift power venting system by homeowner

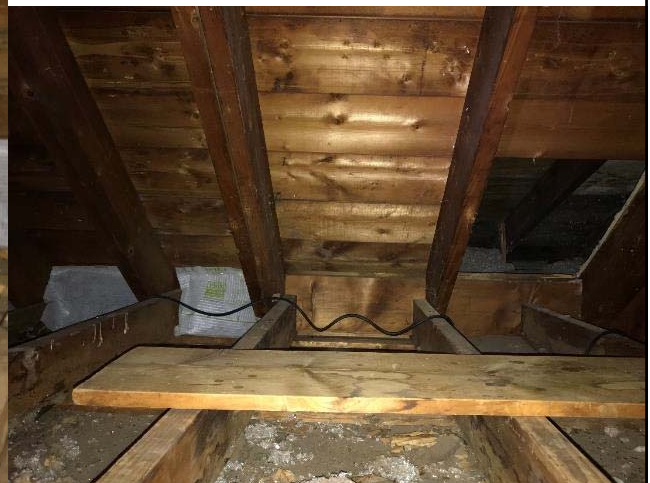
Insulation prep

- Cut openings to dormer roofs
- Installed membrane at tops of finished slopes for high density packing

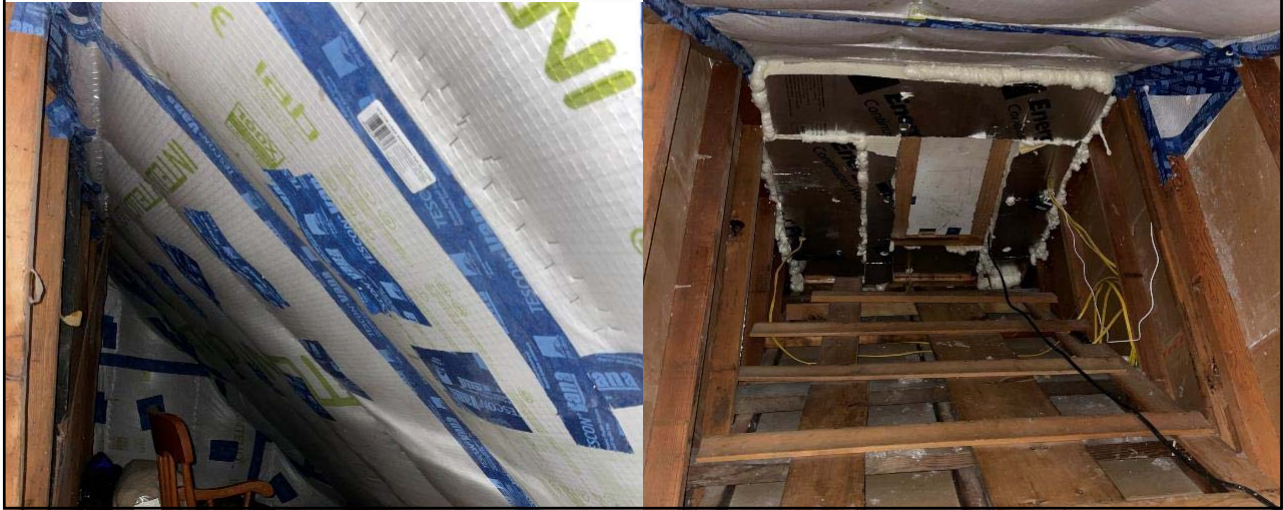
Insulation prep

- Create insulated air tight access to attic
- Install Intello membrane on rafters

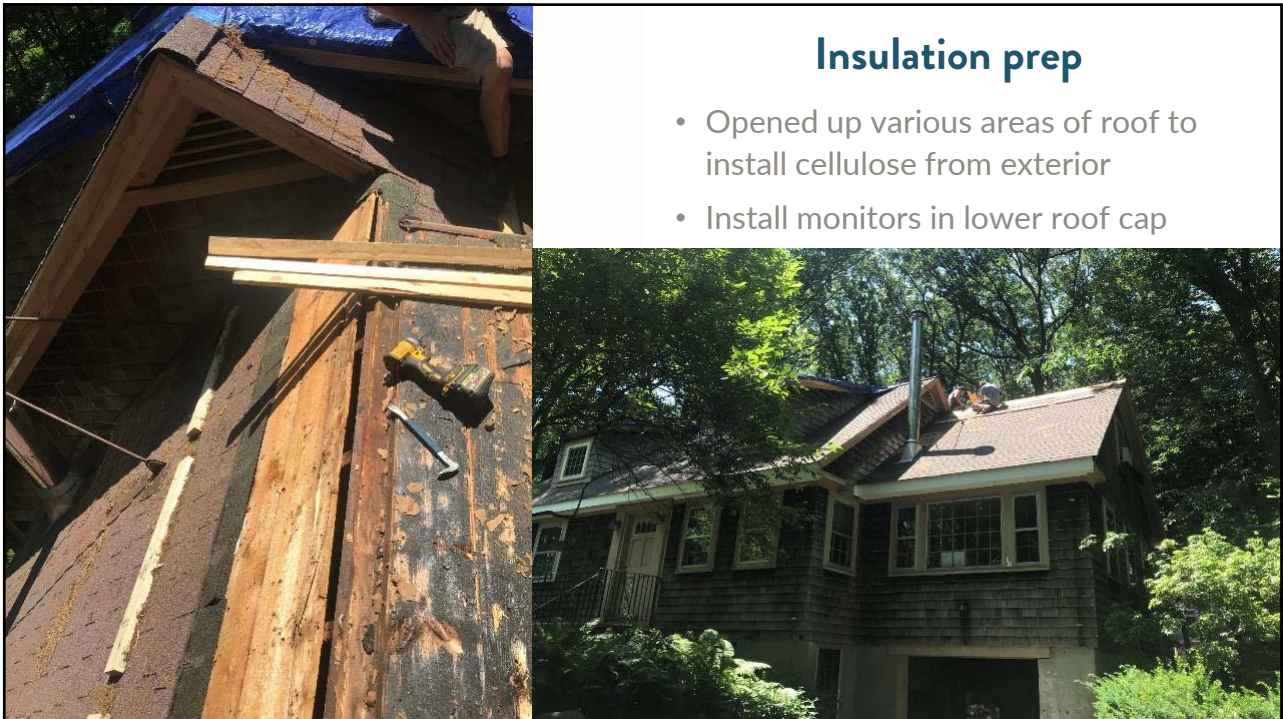
Insulation prep

- Opened up various areas of roof to install cellulose from exterior
- Install monitors in lower roof cap

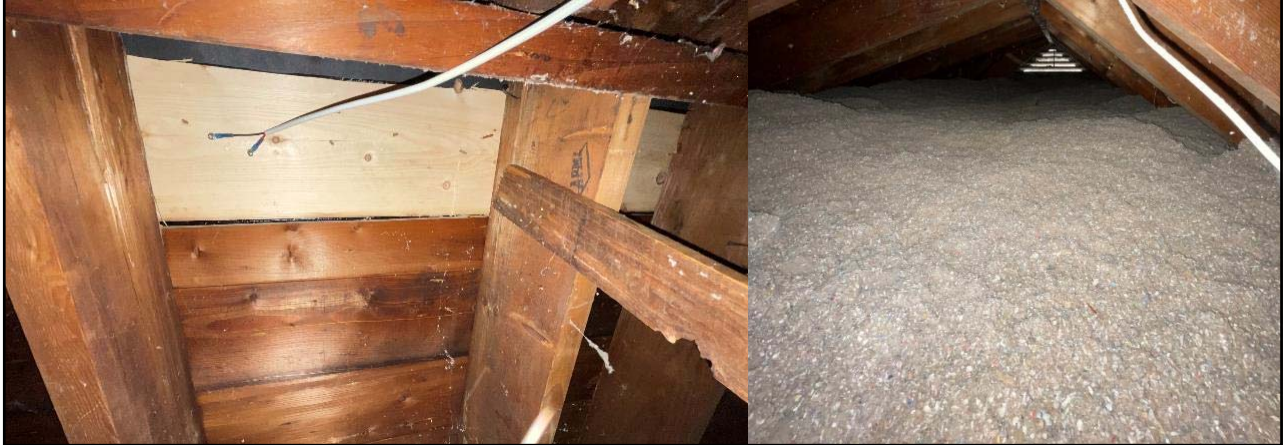
Monitor & Insulate

- %MC monitor in roof sheathing near ridge
- Temp & RH installed in attic below ridge

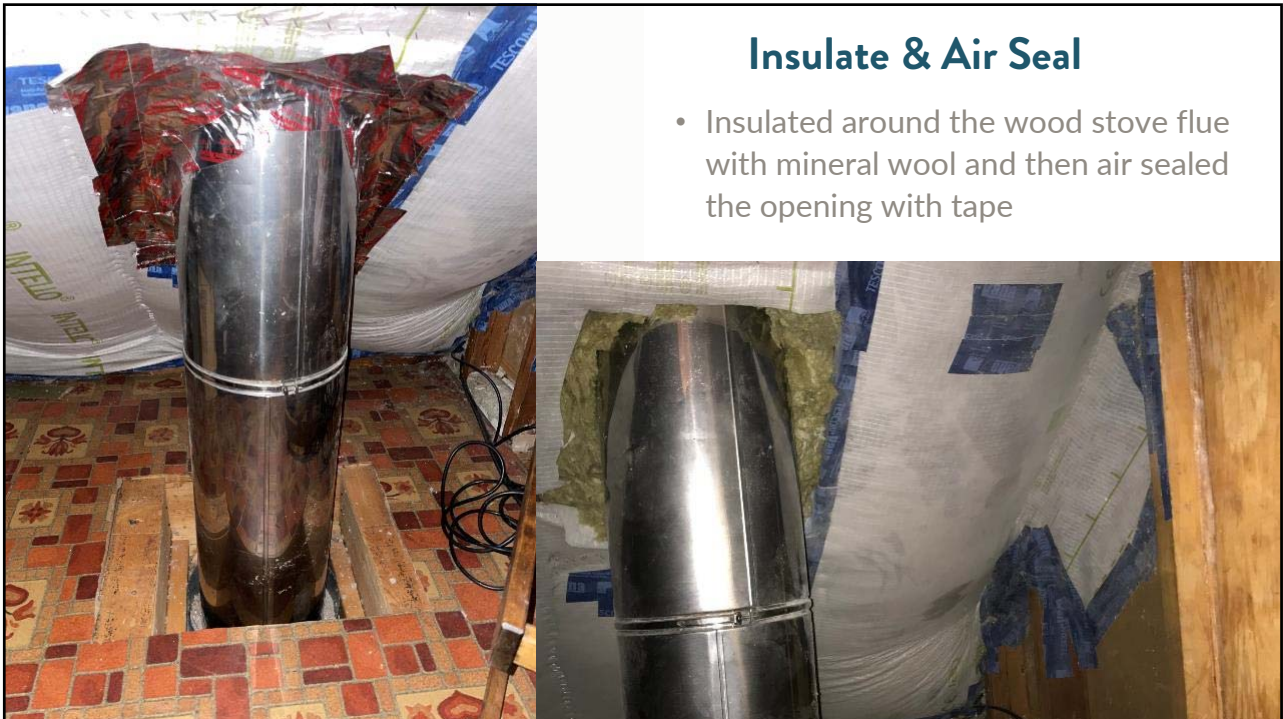
Insulate & Air Seal

- Insulated around the wood stove flue with mineral wool and then air sealed the opening with tape
