Simplicity and Contradiction

15 years in the making of *net better*

DGR- 4 Amherst Road

BE 2016

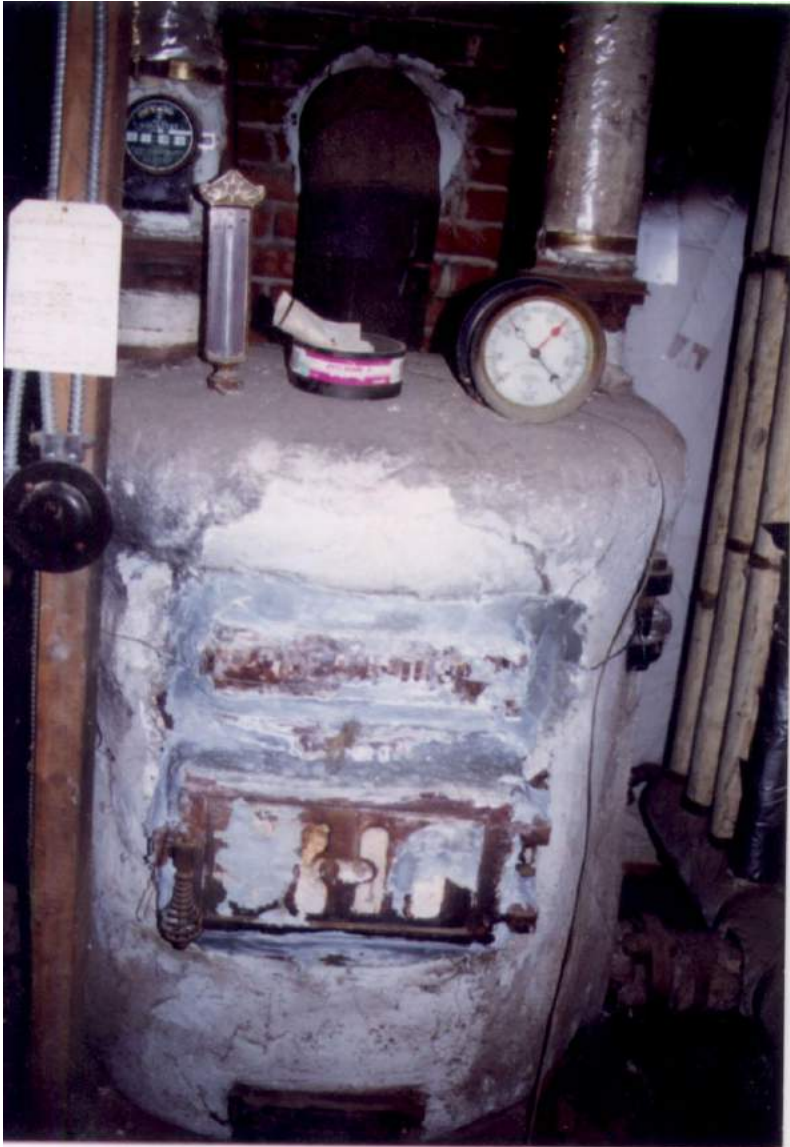
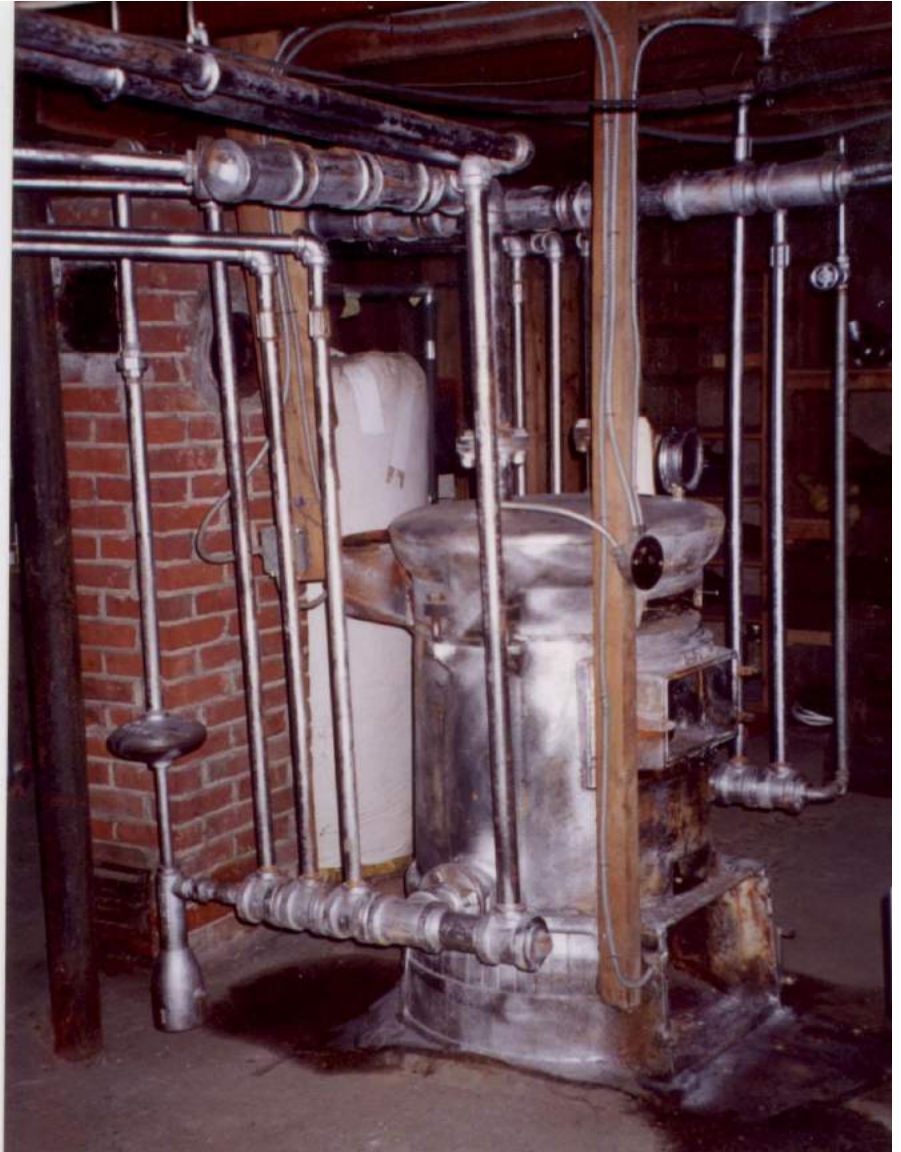
Snowman boiler with asbestos and electric hot water

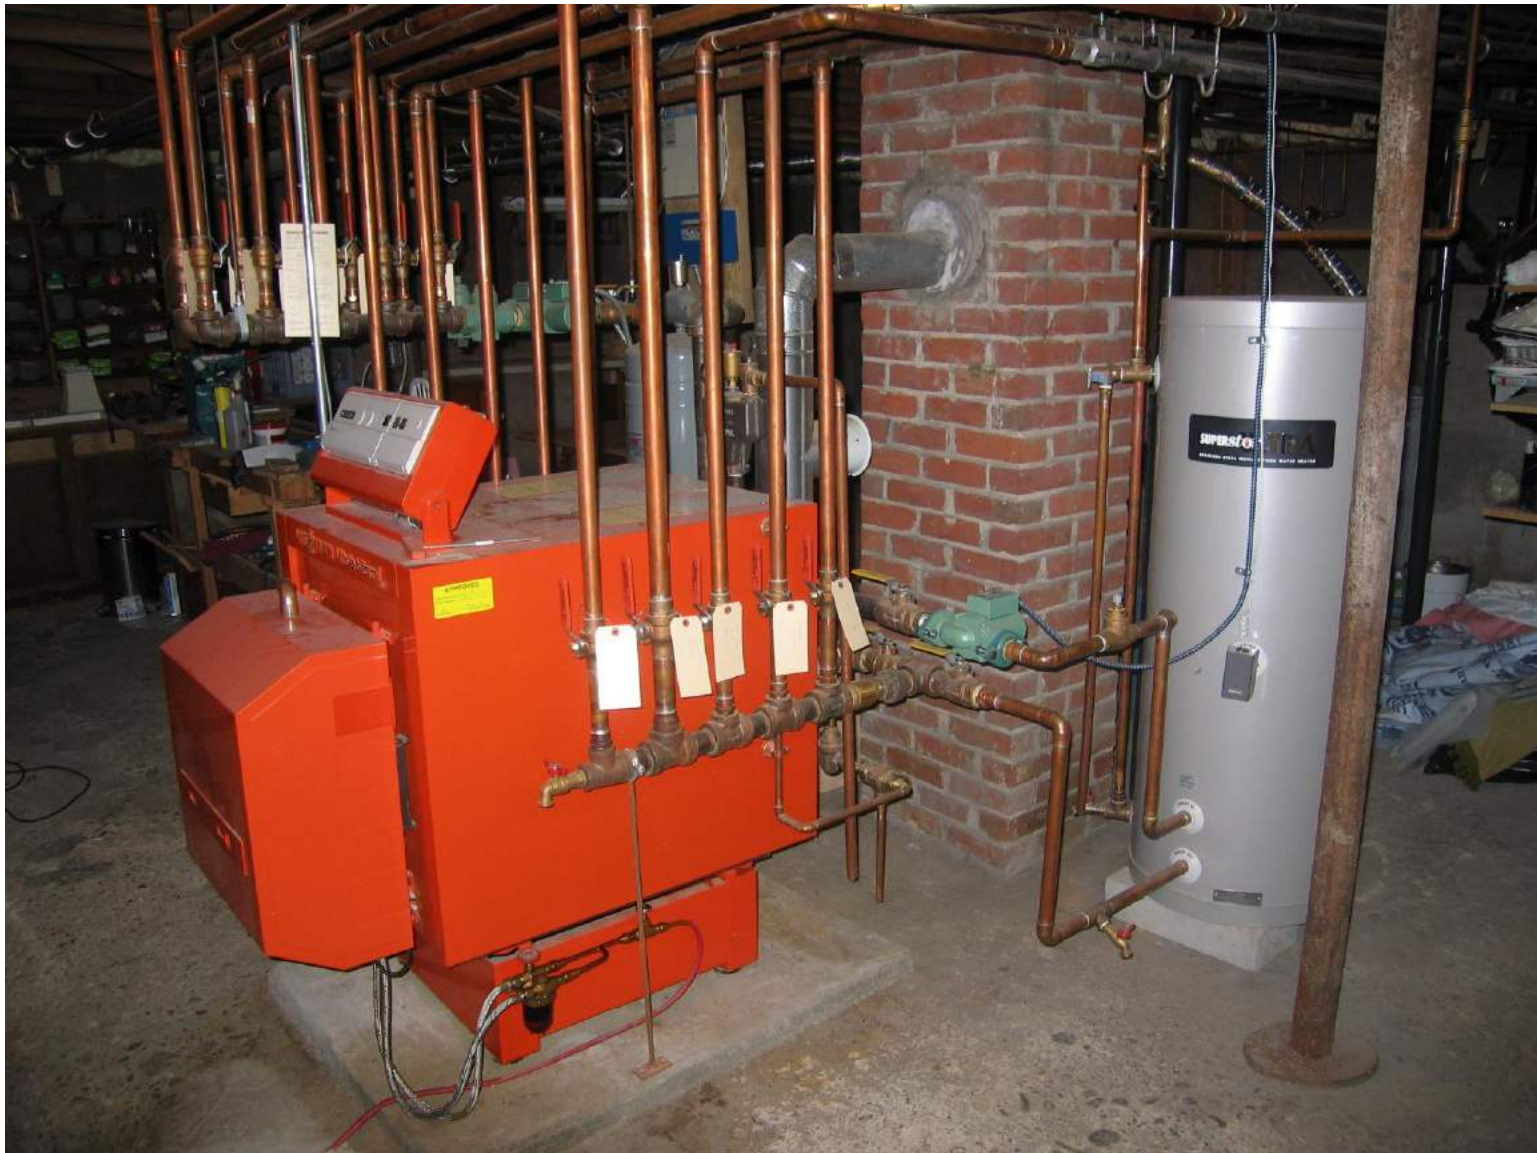
New boiler in 2000 and indirect tank for hot water in 2002

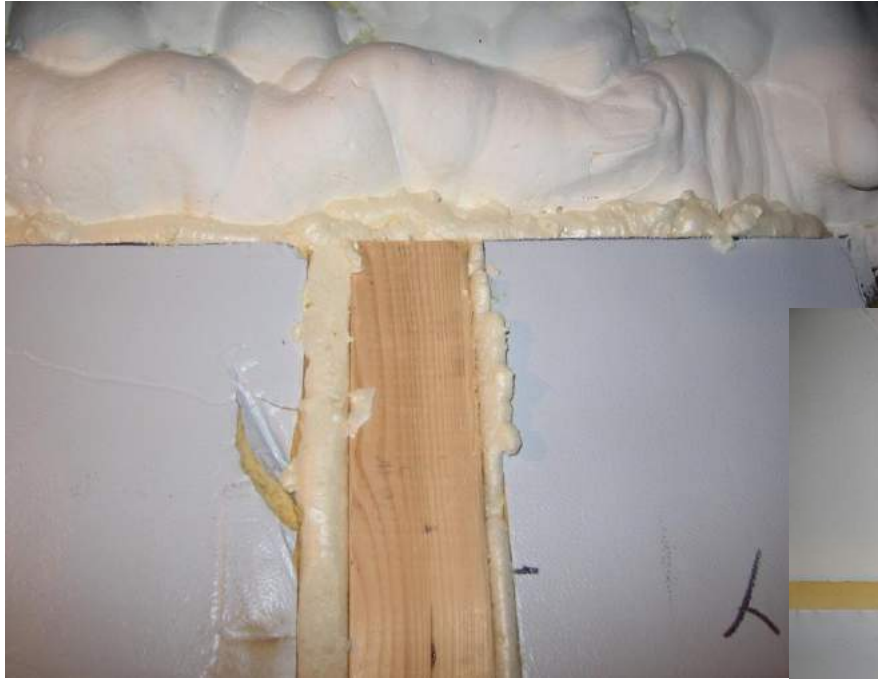
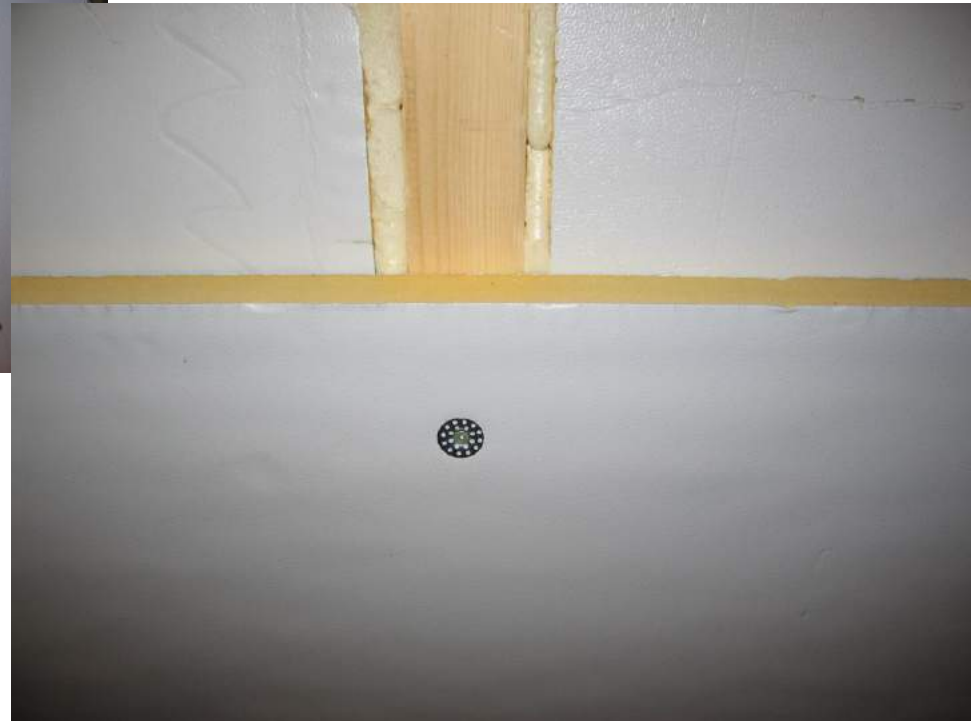
2004- insulate bandjoist with Icynene and intumescent paint

2008- 2 layers of 1 ½" Thermax Insulation on the concrete foundation walls

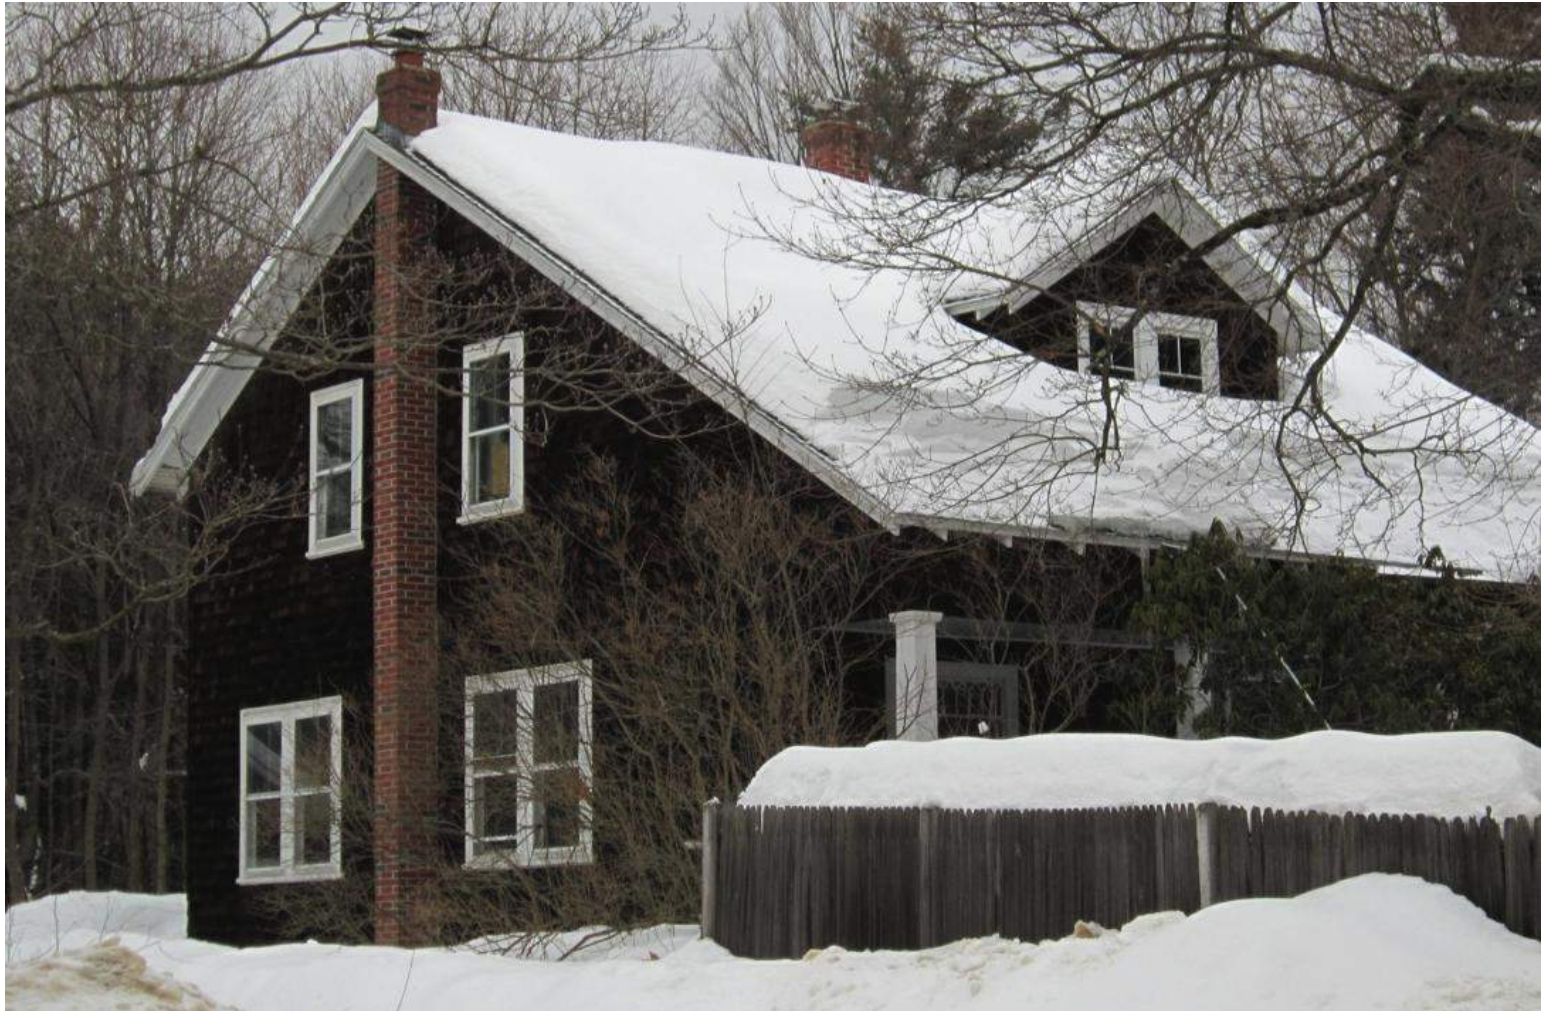
2009- Harsh winter-
The house across the street built at the same time has major ice dams

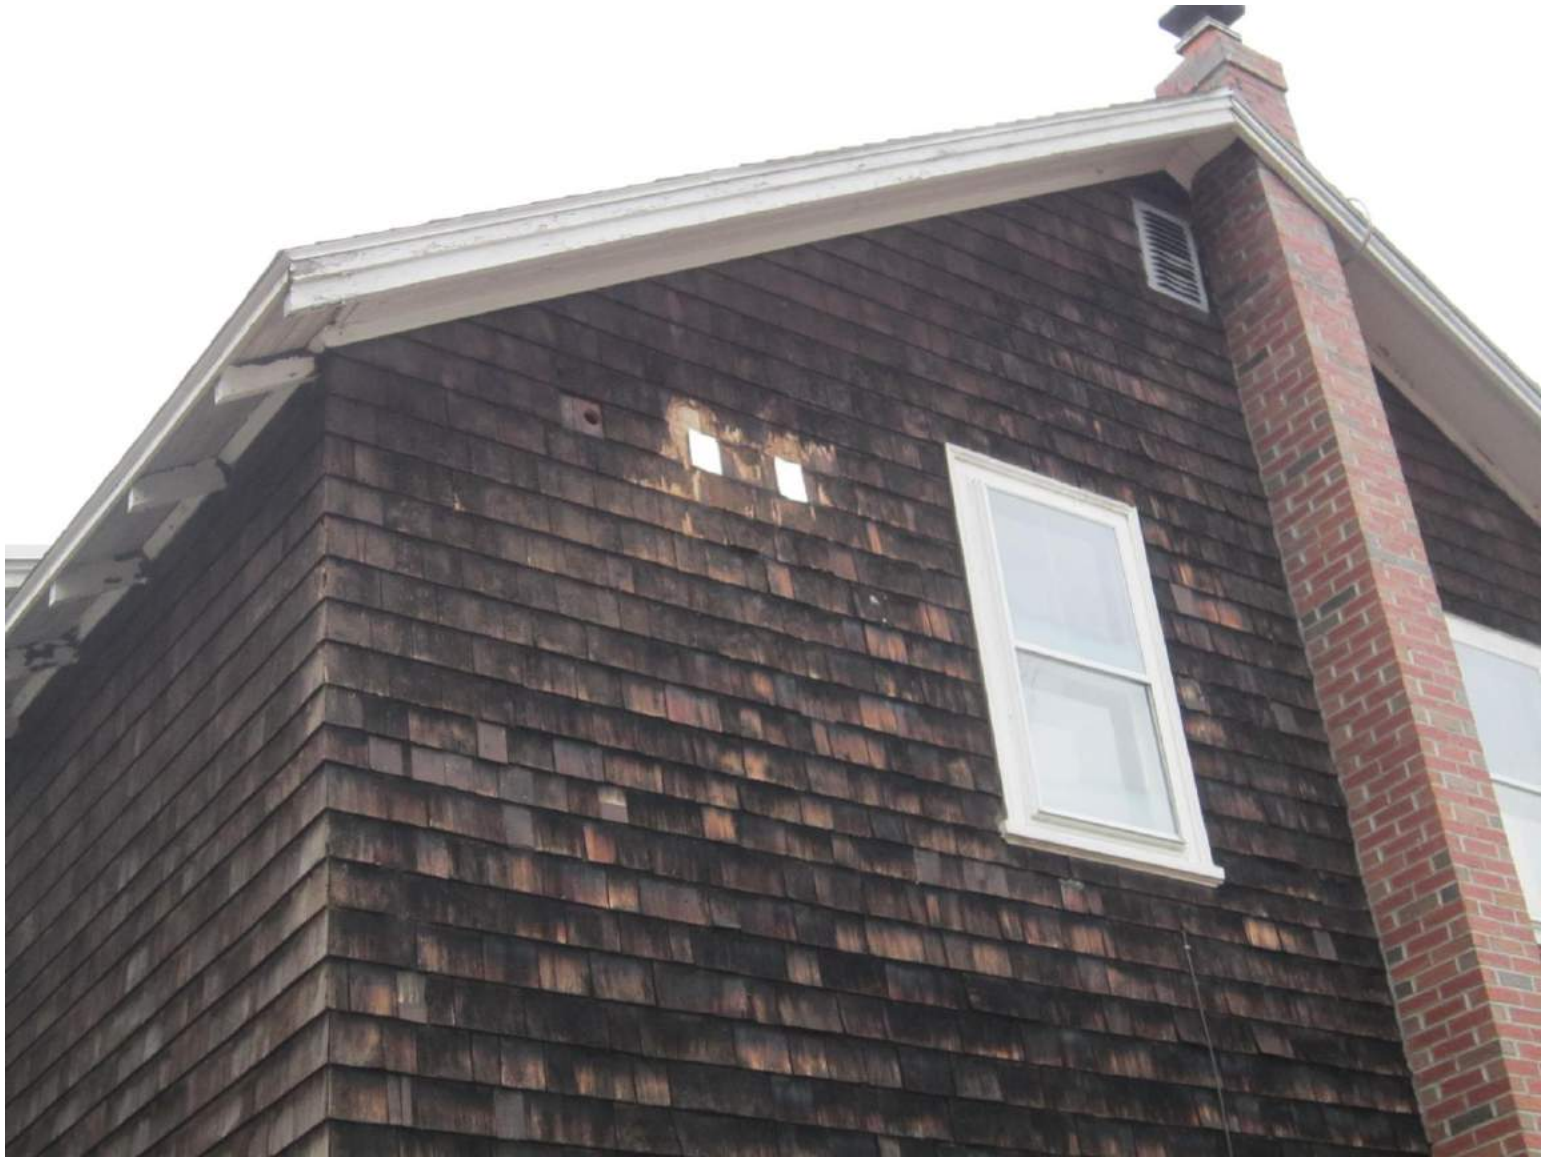
Grey Squirrels!!! – getting into 1970's fiberglass insulation-
Flying squirrels in the attic too!

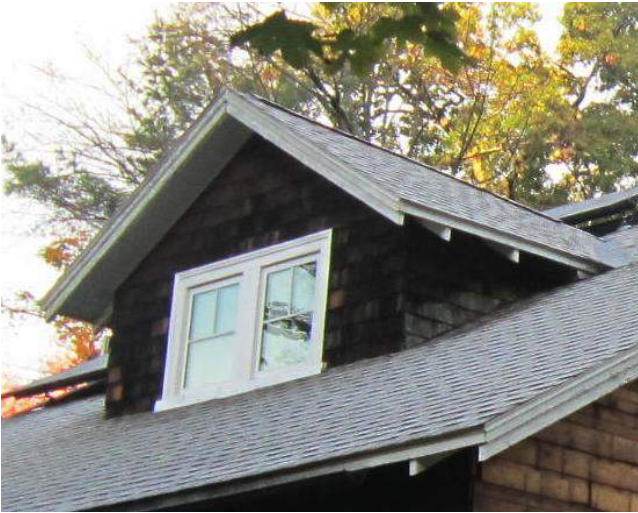
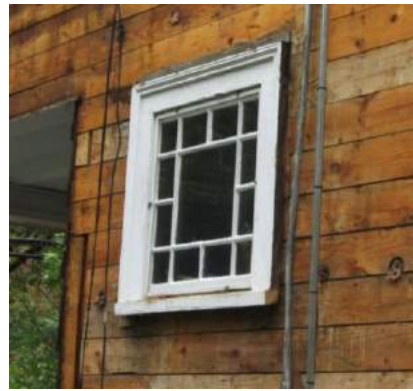
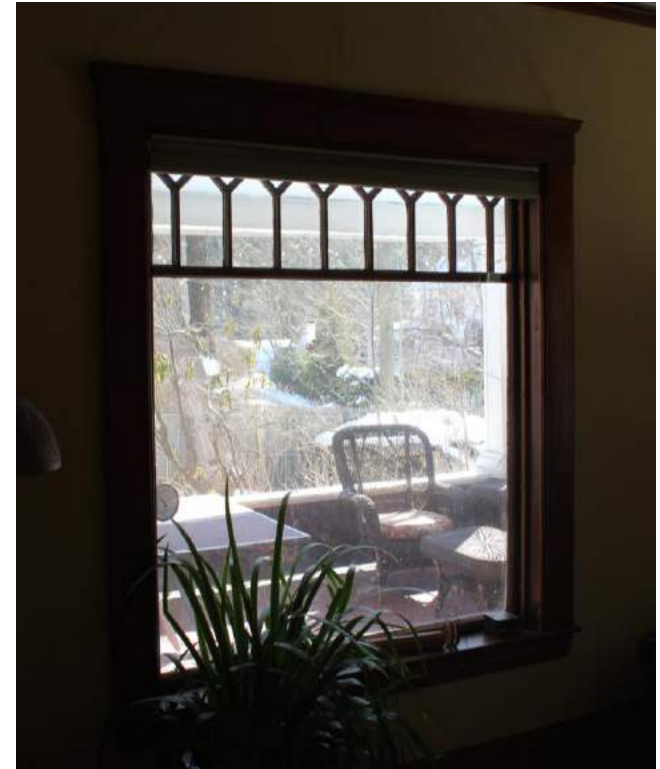
The front dormer windows were replaced in 2010, and given the complexity of redoing the roofing step flashing, I decided to only re-shingle and not add 3" of insulation here.

Two single glazed fixed accent windows were not replaced. Both received plexiglass storm windows on the exterior. The large picture window on the front received plexi on the interior as a safety concern. (Boys throw things).

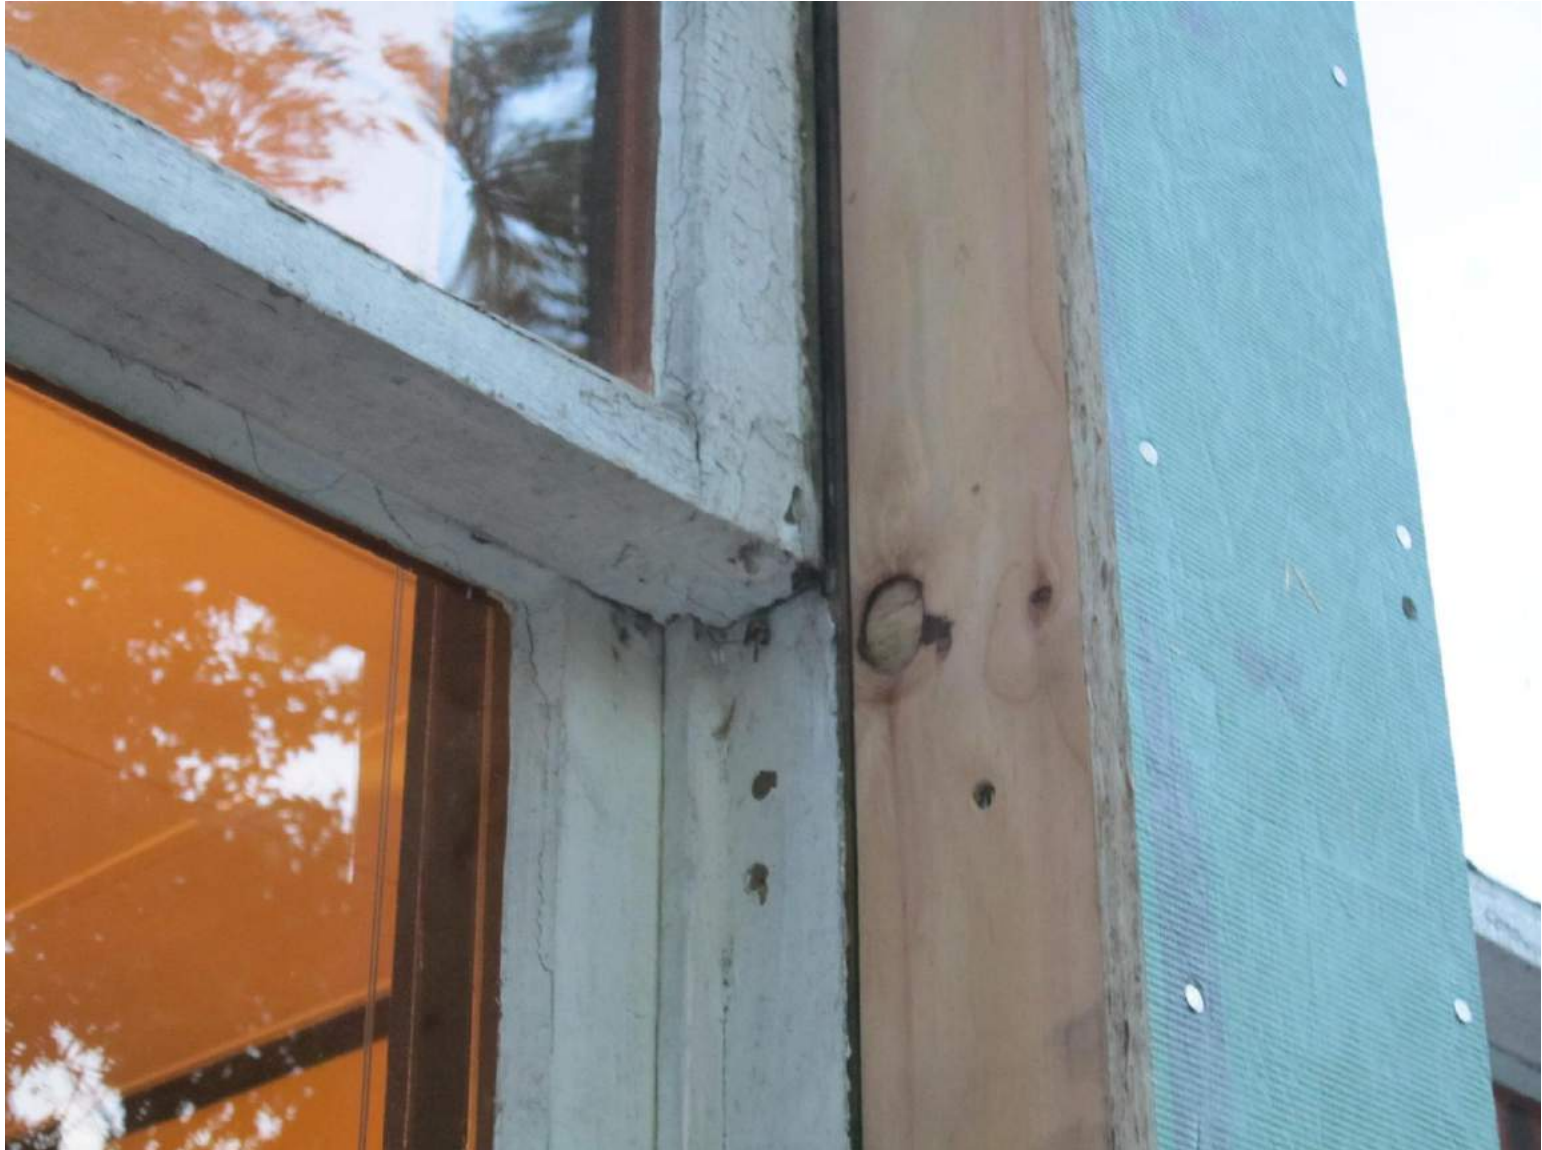
Window detail

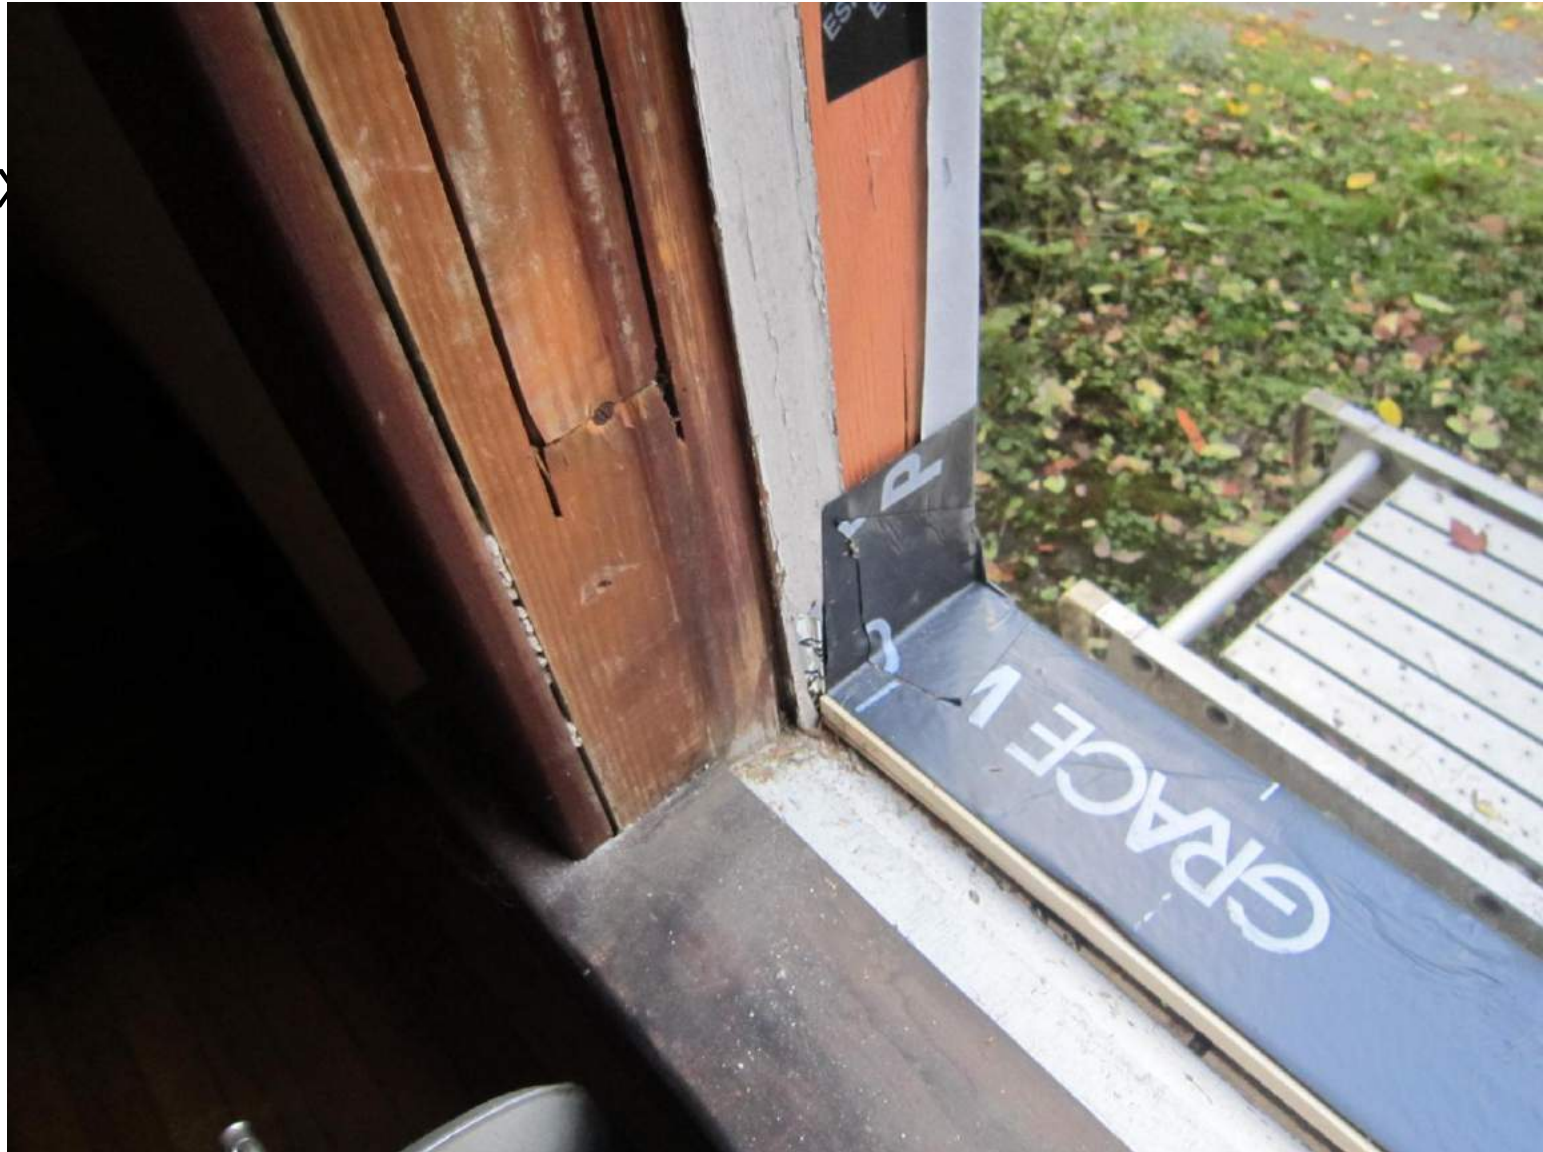
Thickened wall

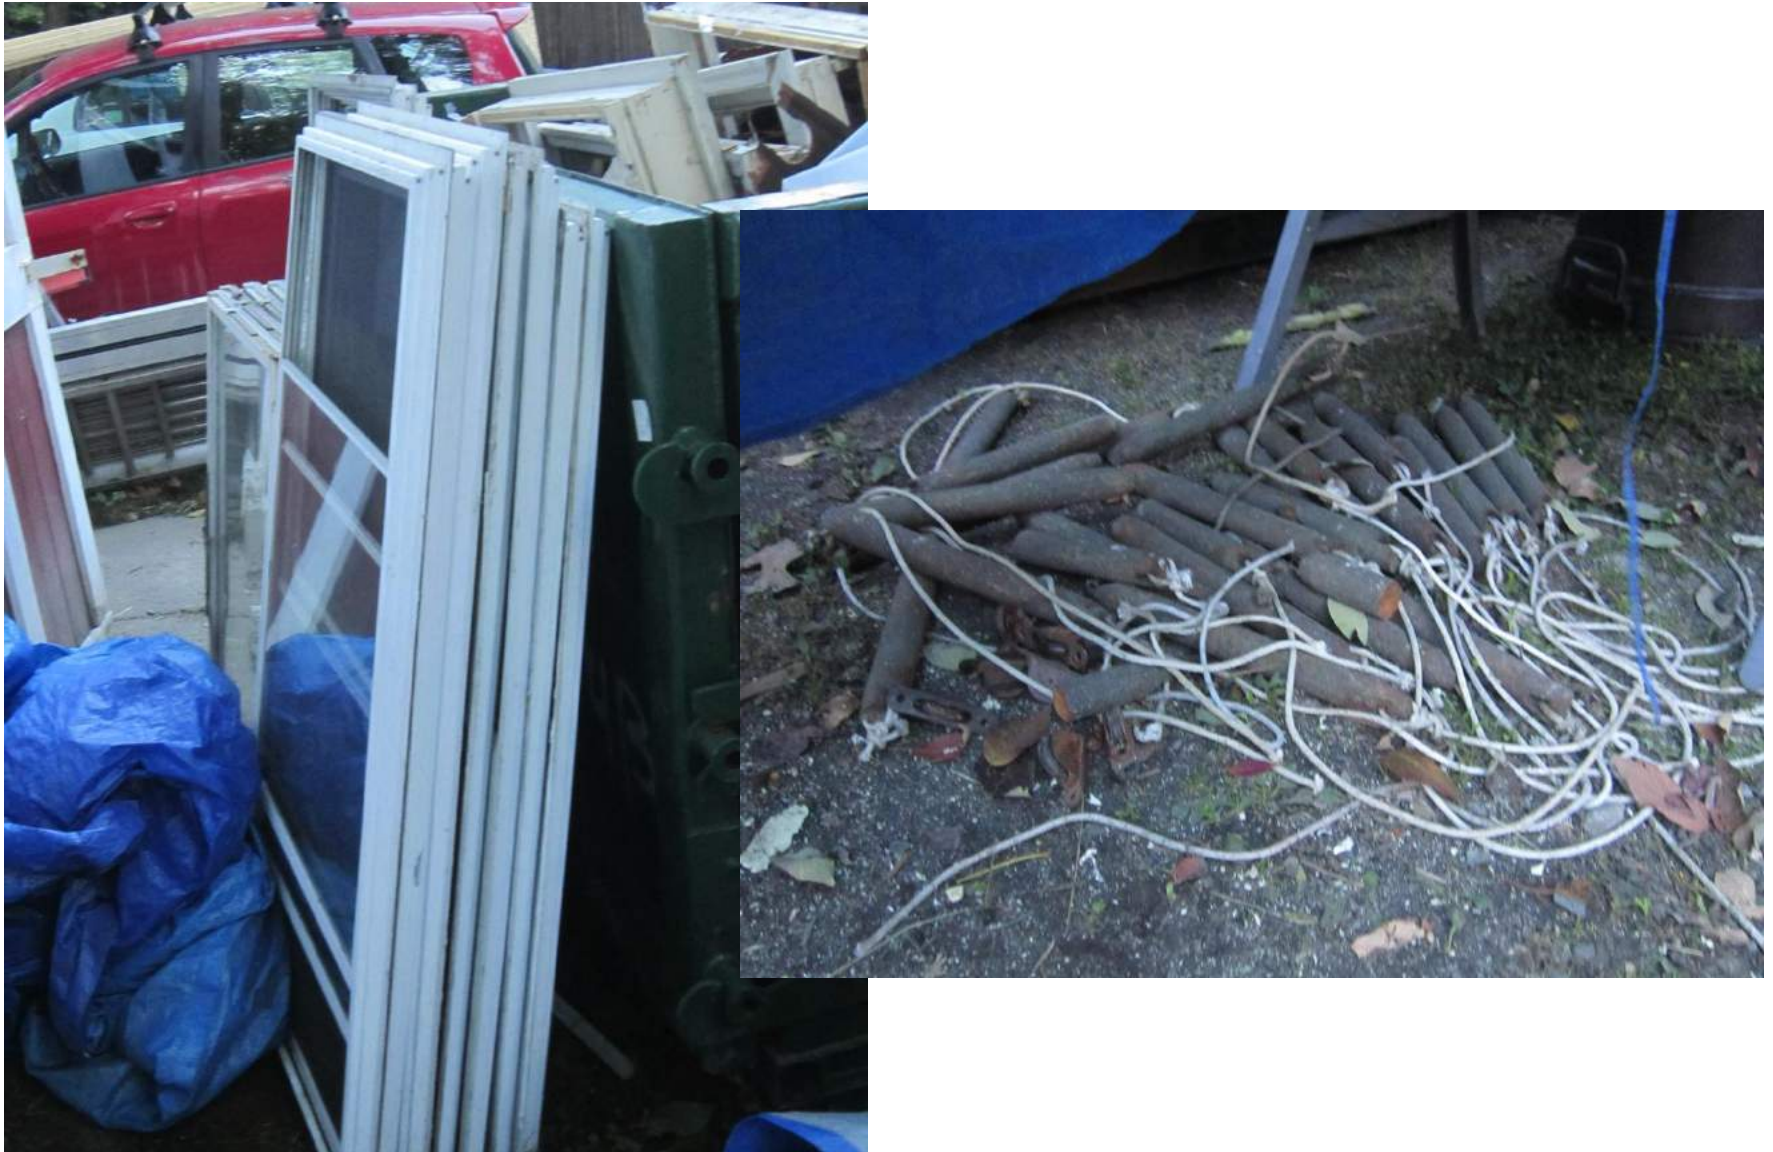
Storm windows salvaged for re-use and window weights to scrap metal

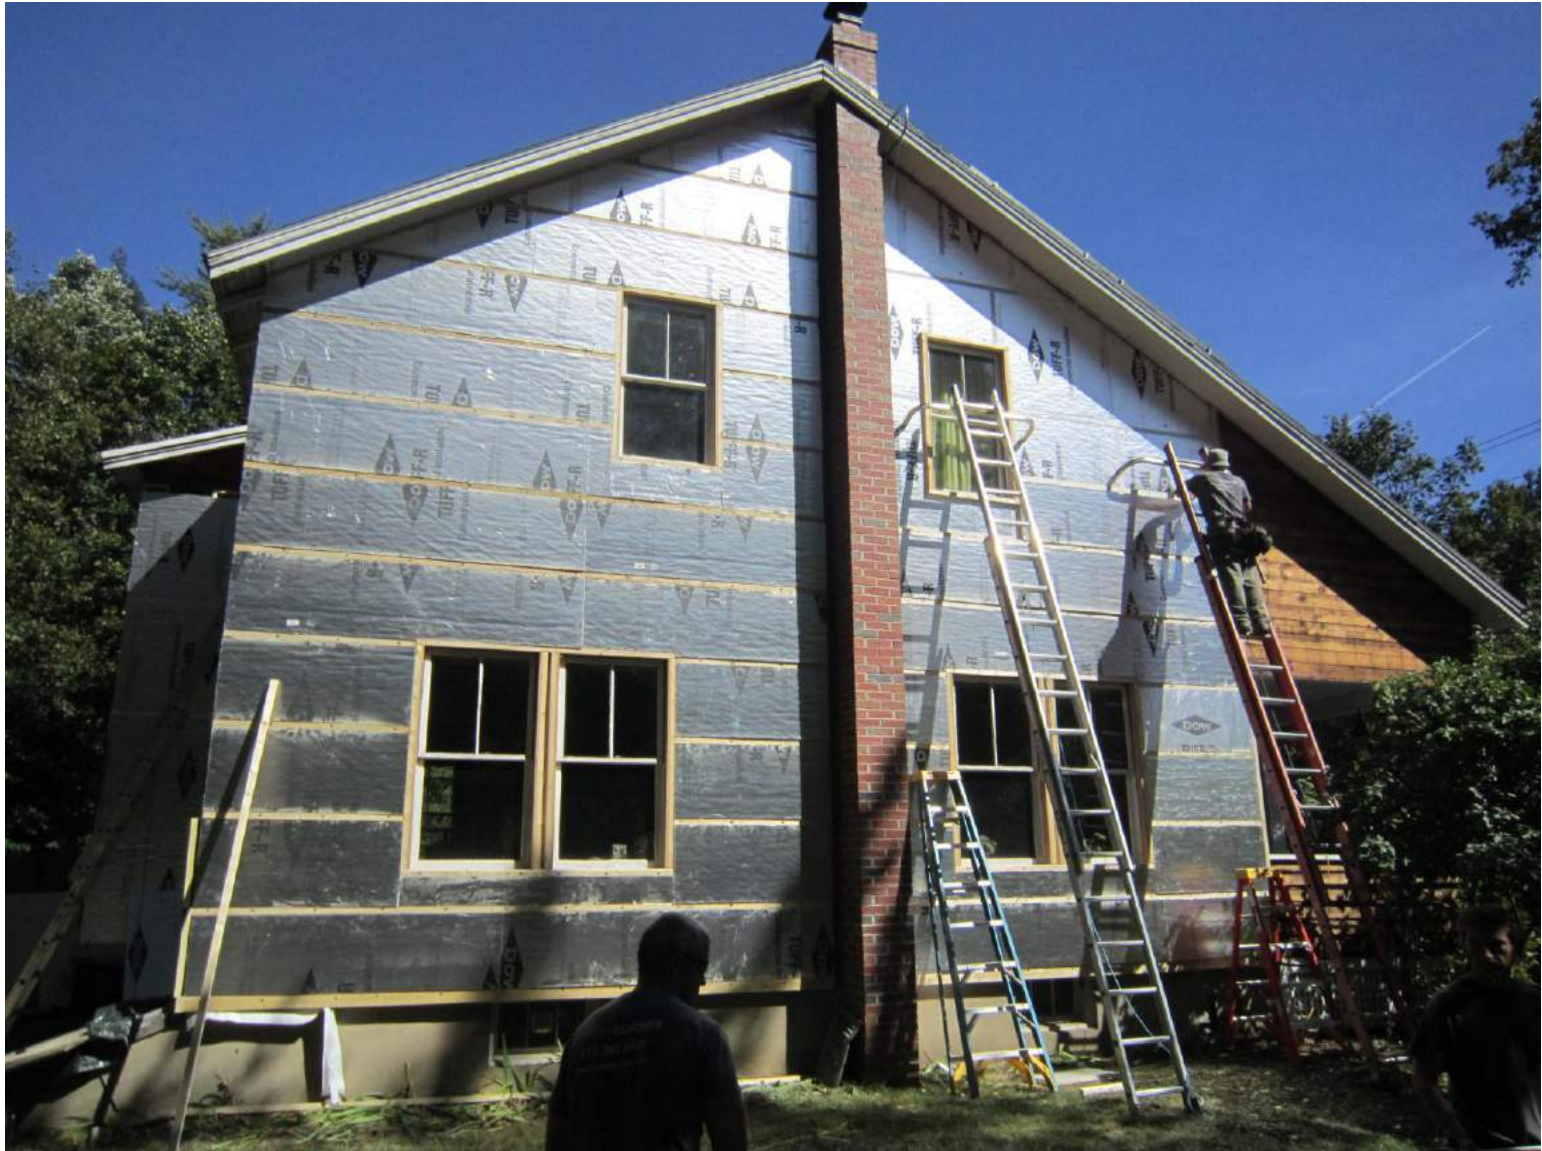
Second Layer of Polyiso

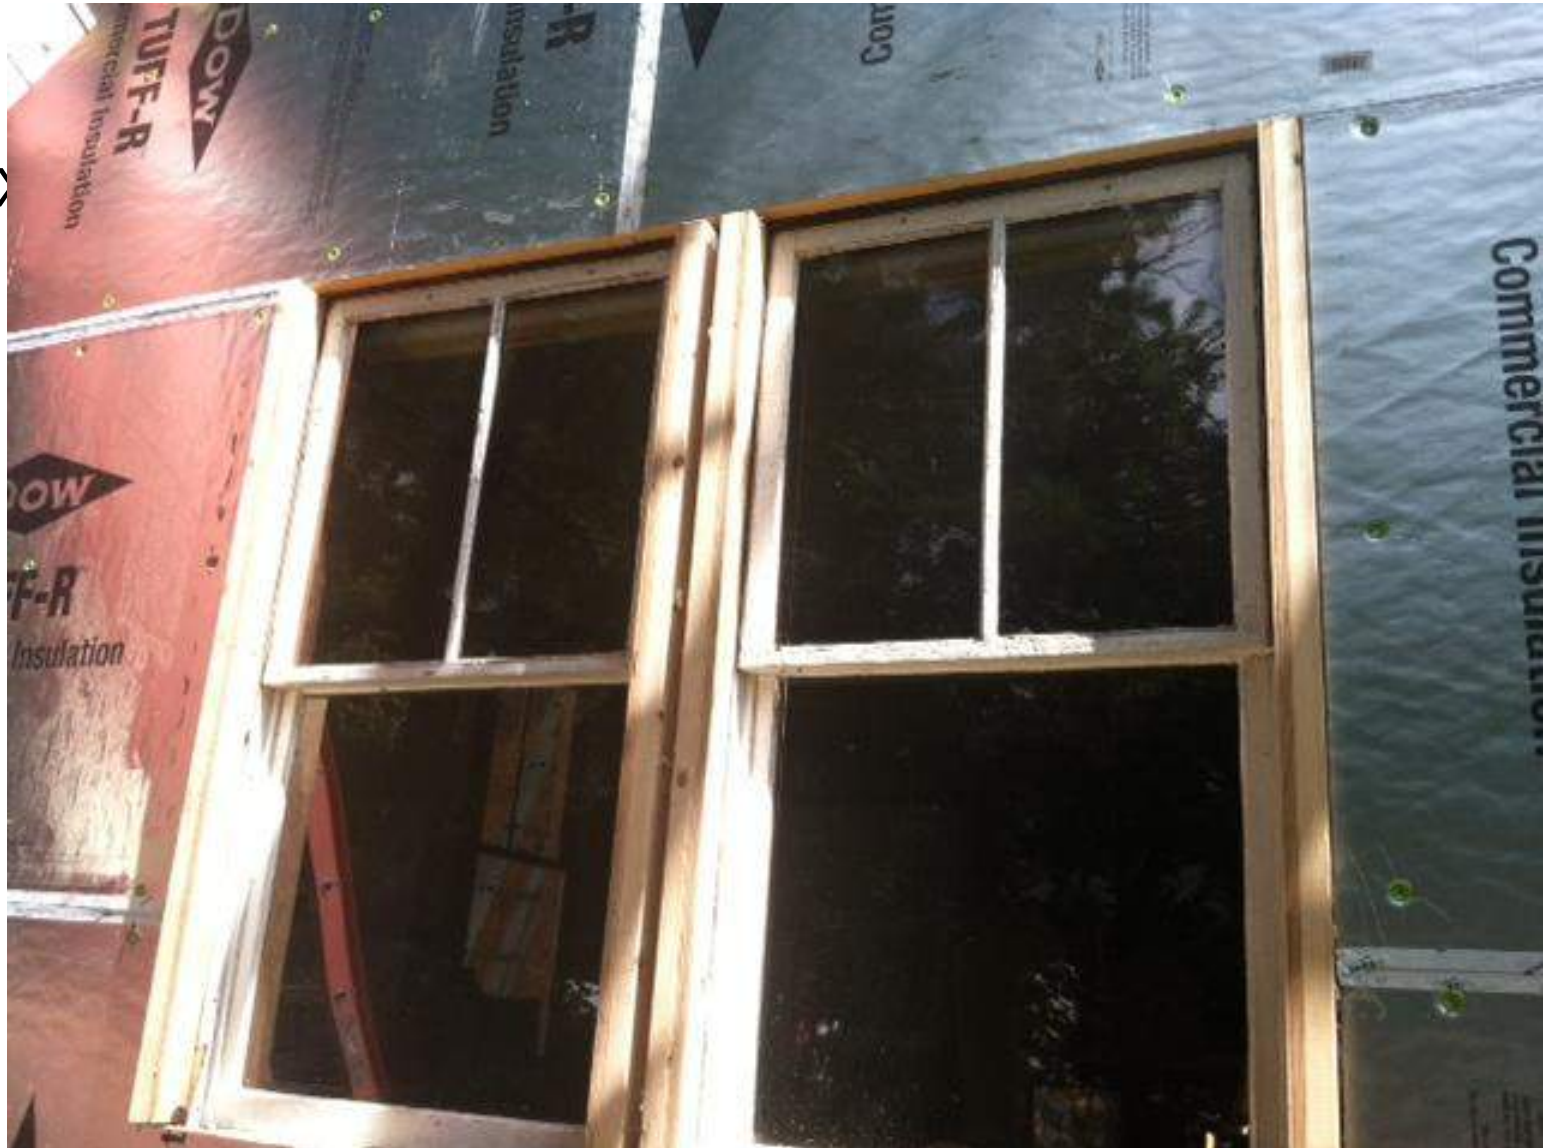
Minimal disruption- sashes stay in place until new unit installed

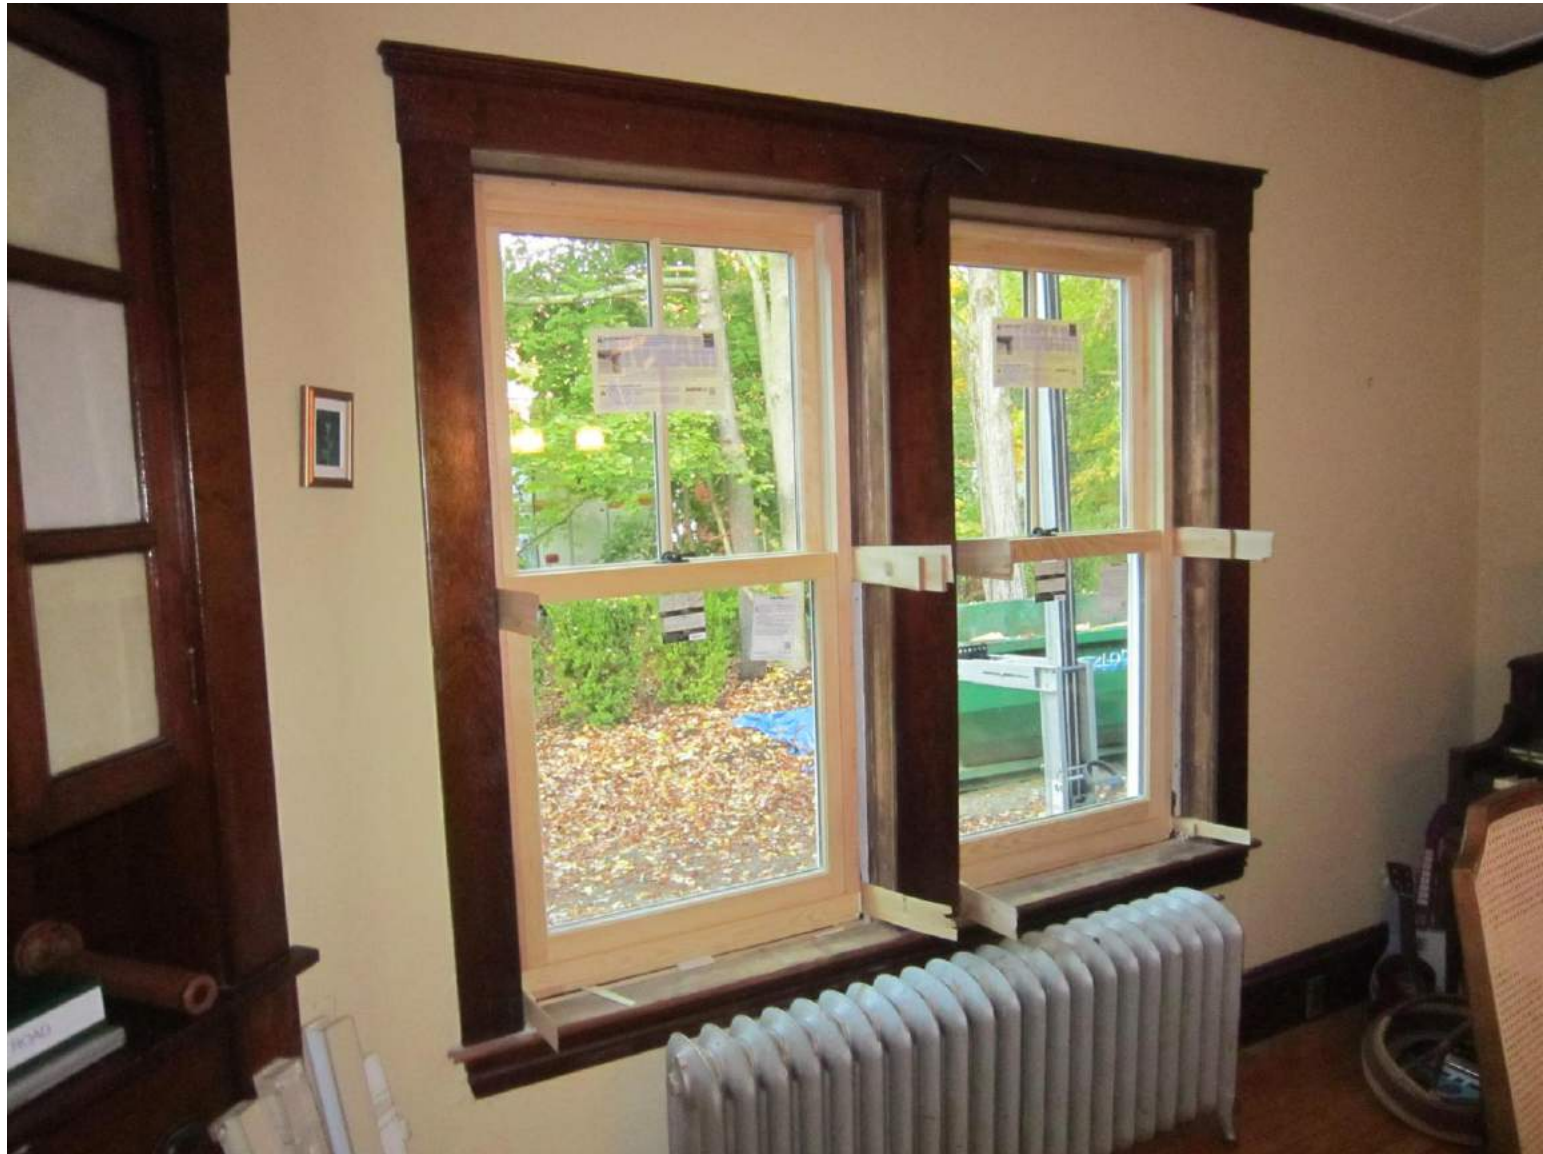
Maintain existing trim, but with reduced glazing area - ☹️

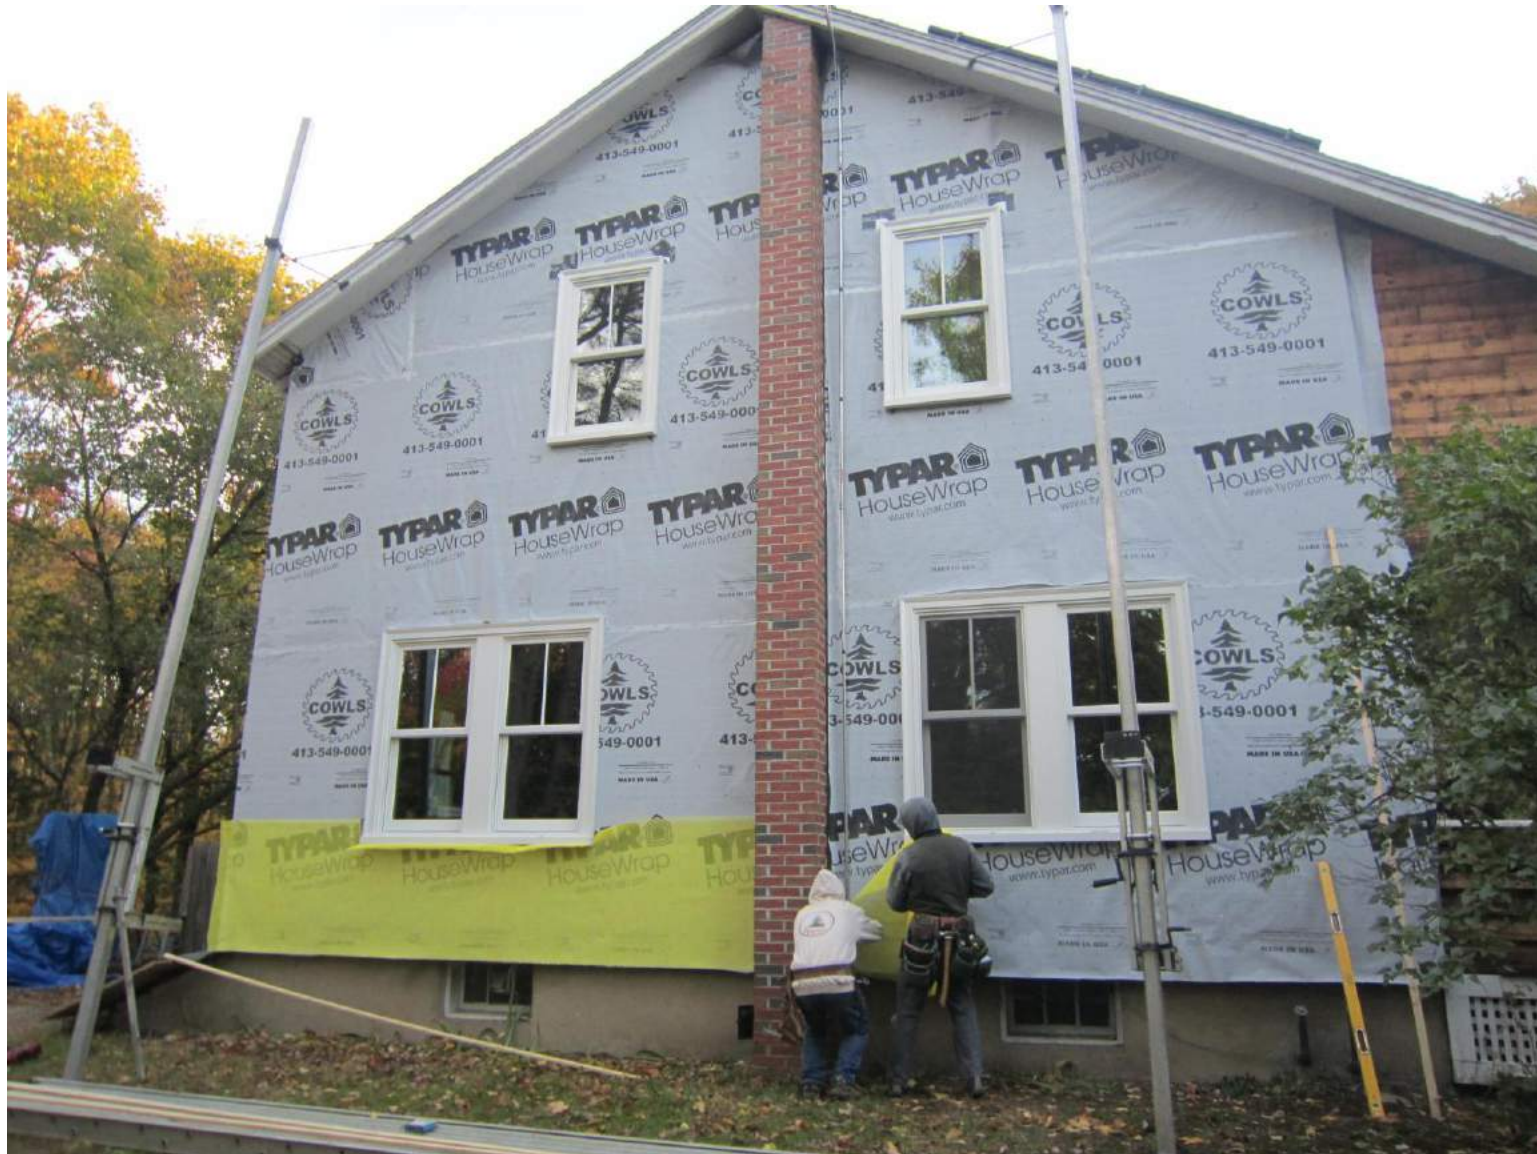
House wrap and home slicker, casings look great.
