Simplicity and Contradiction

15 years in the making of *net better*

DGR- 4 Amherst Road

BE 2016

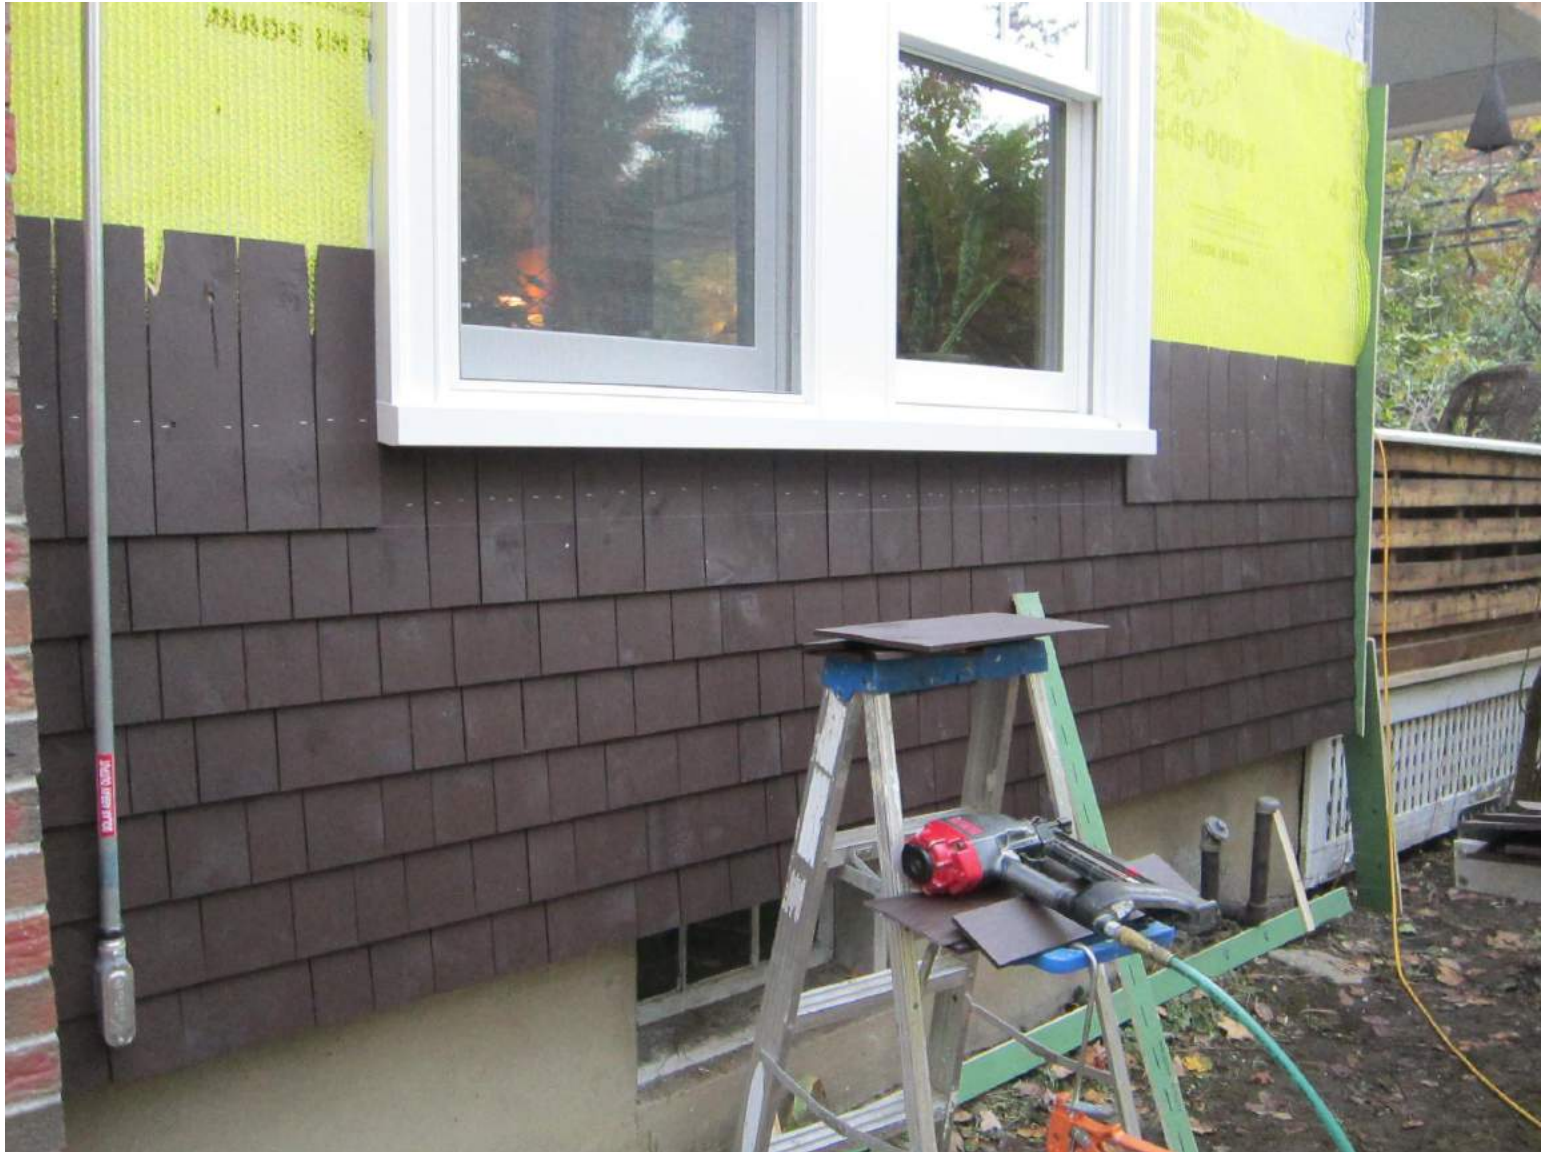
Pre-stained shingles to match original going on

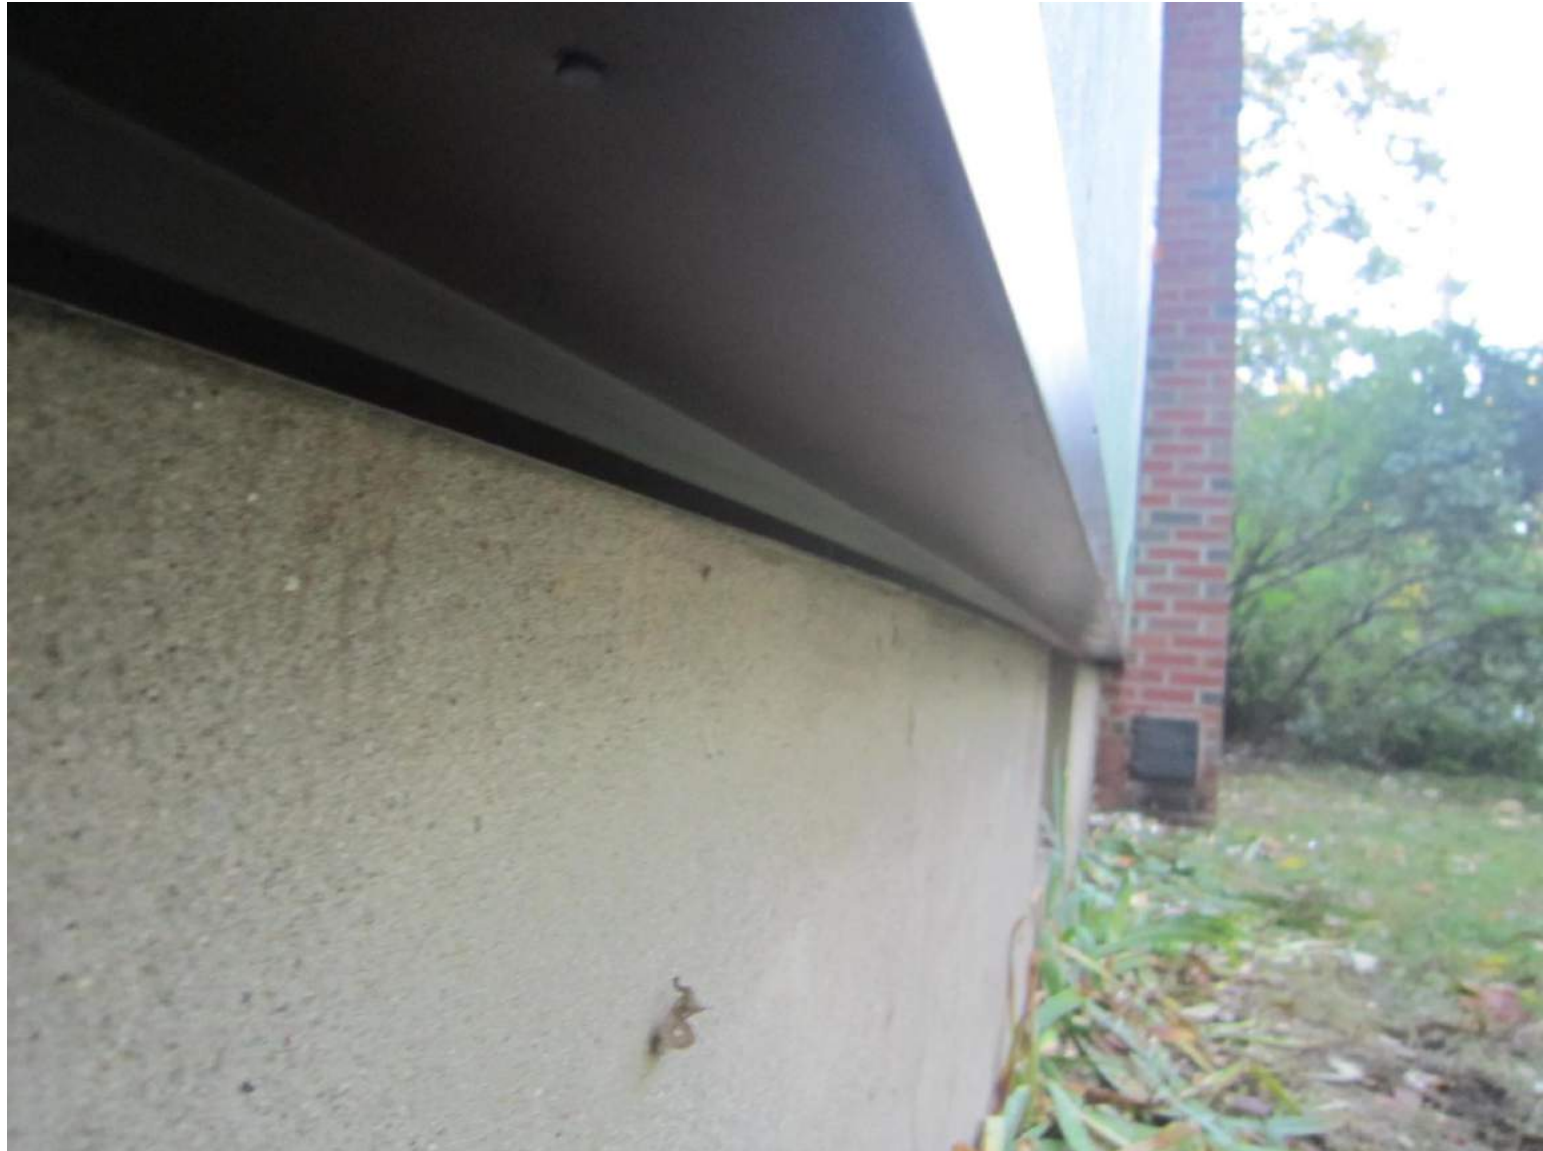
Break metal flashing sealed to foundation wall to protect foam

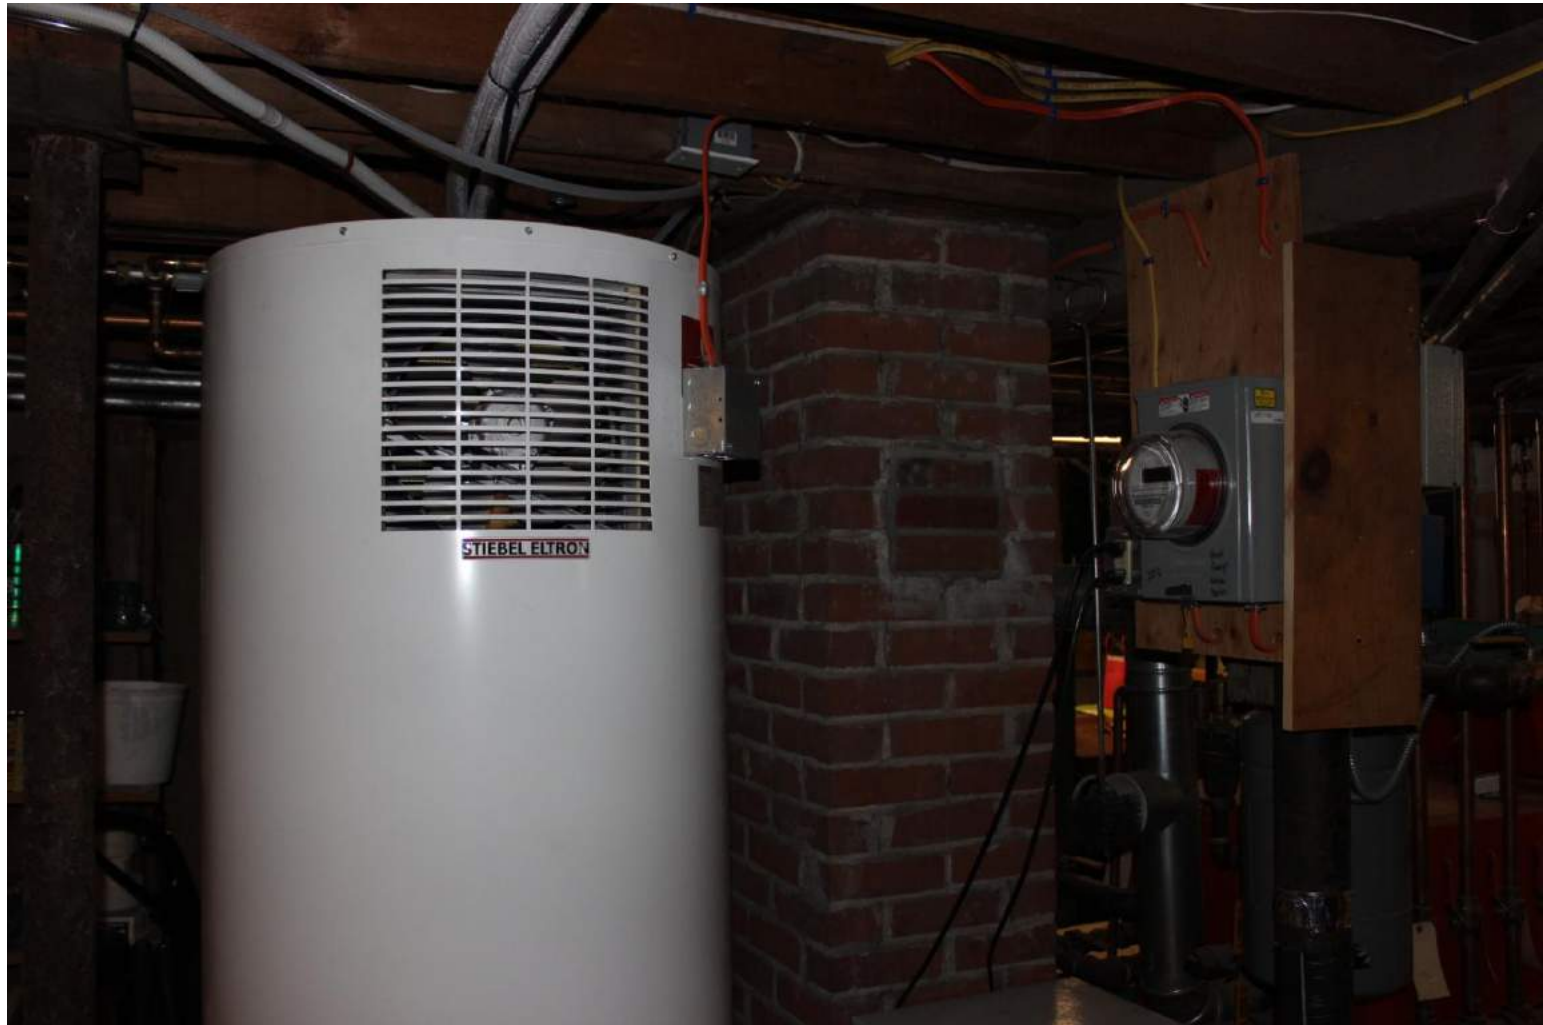
Water heater Heat Pump Metering

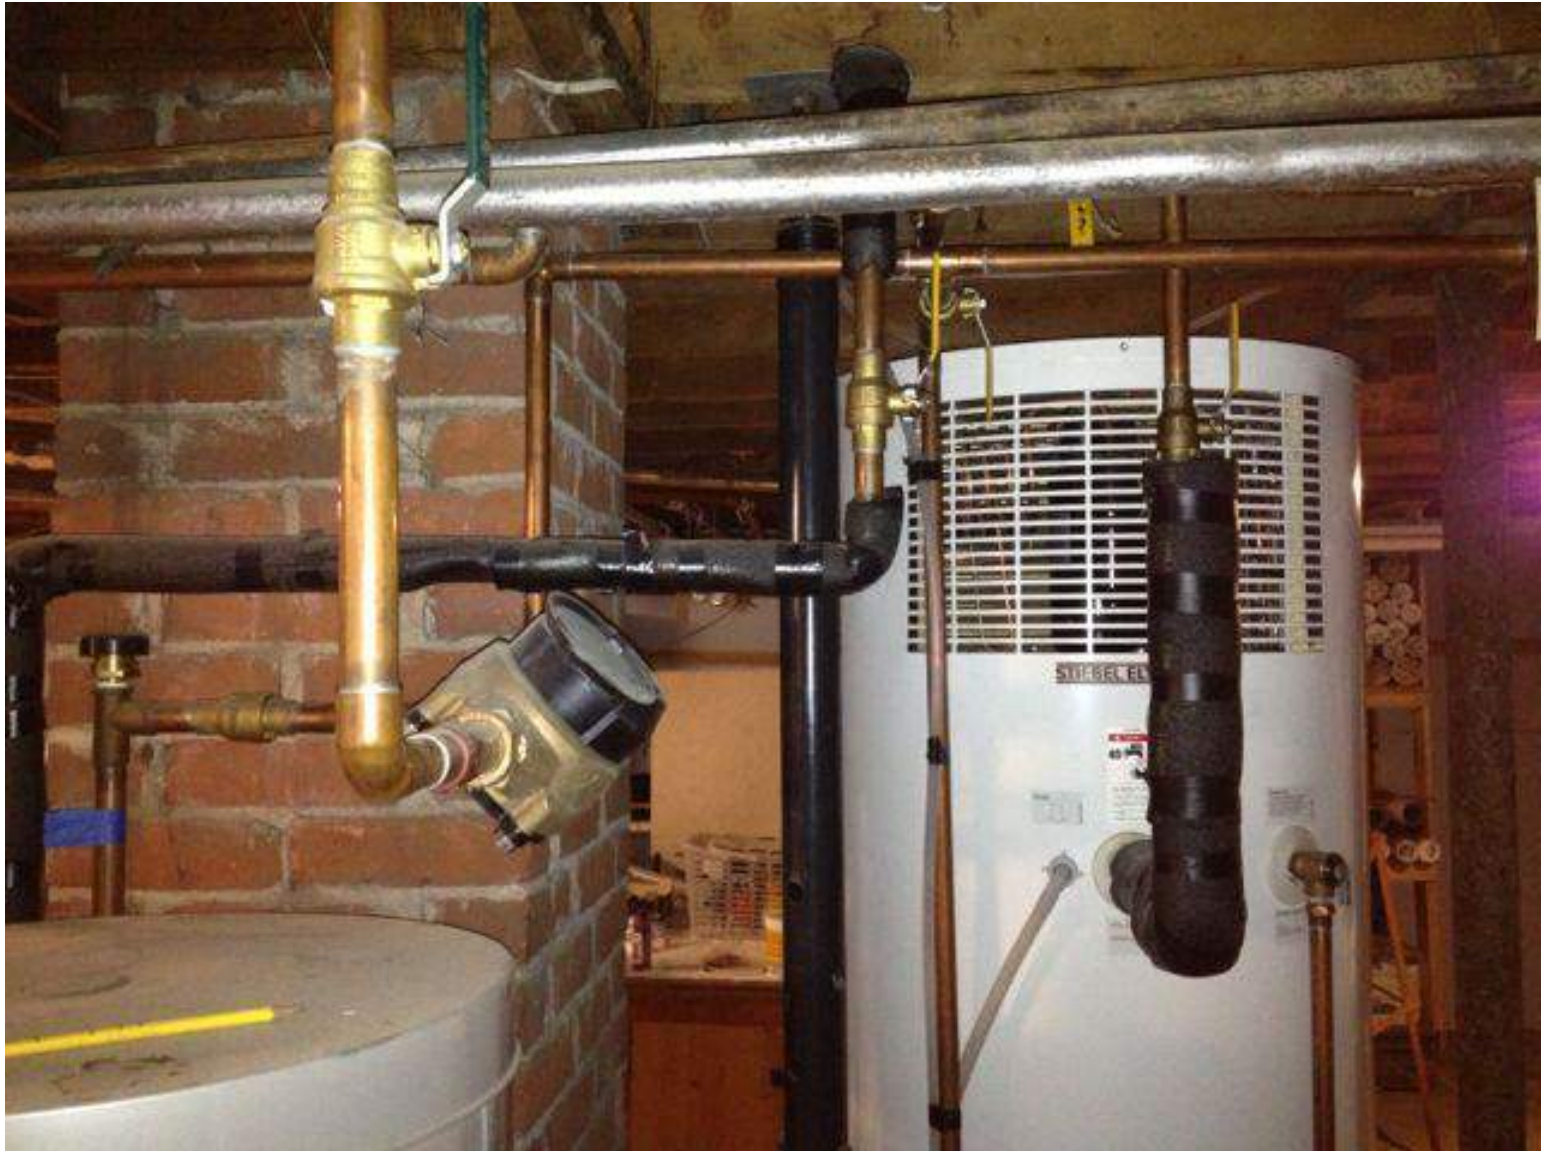
Hot Water Metering- flow meter on cold inlet

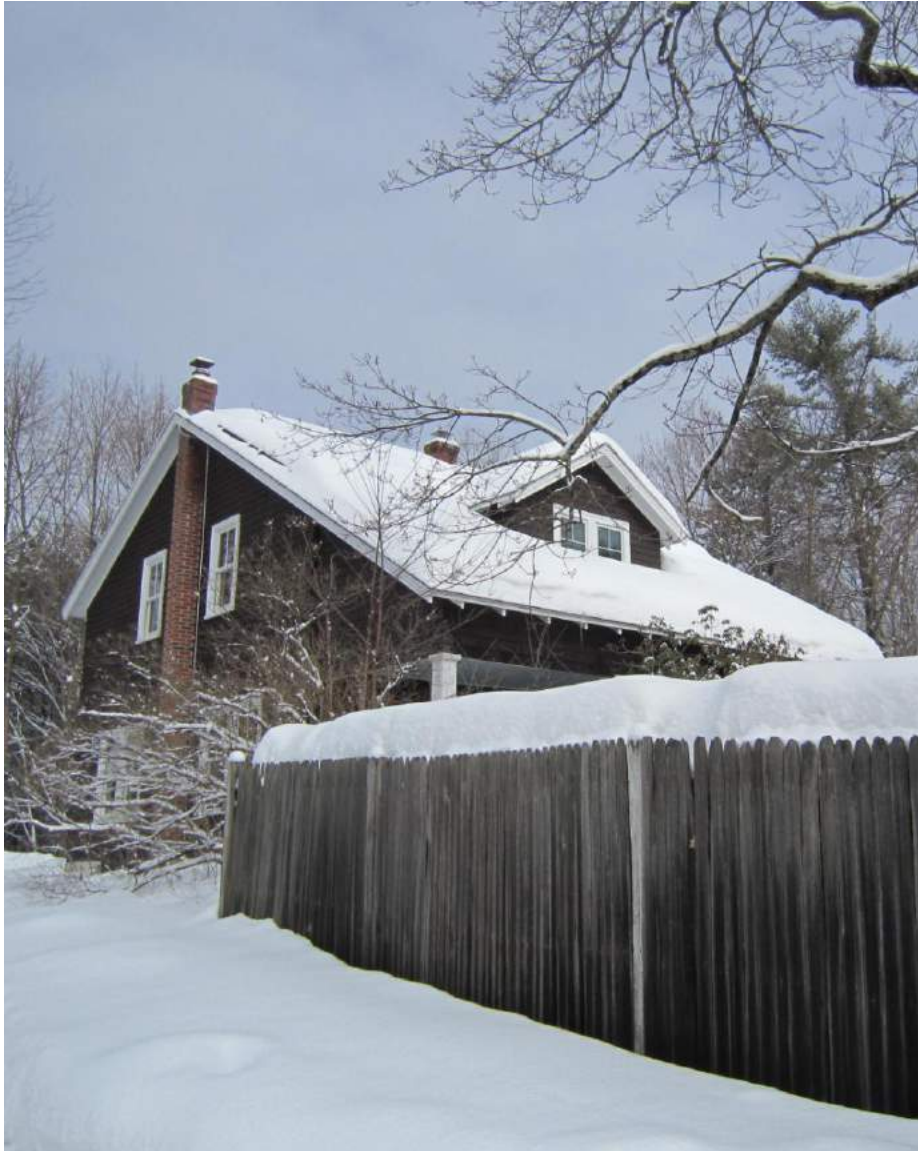
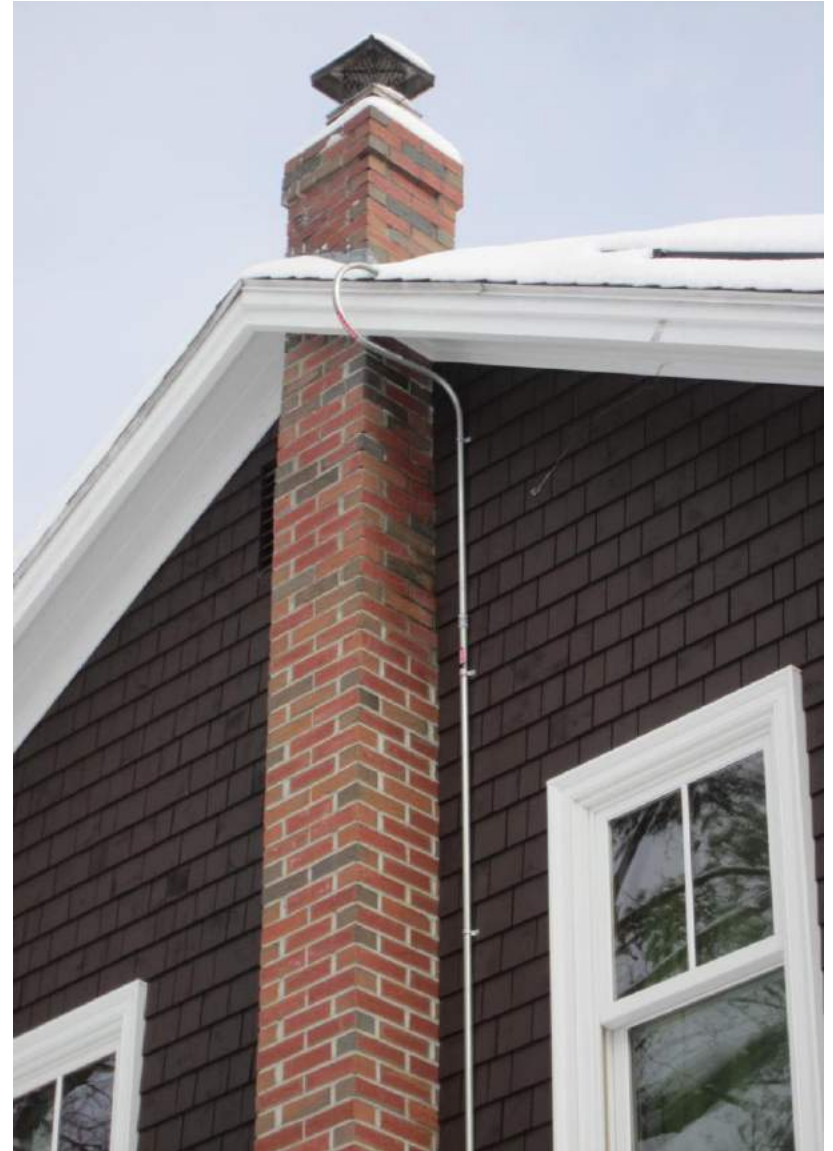
Chimney problem

1. Use flash spray of closed cell foam on the attic lathe before adding loose fill insulation. The plaster is cracked and not the best air barrier.
1. Install better insulation over porch by framing a cavity and installing taped plywood rather than just netting. Mice get in. This will be done shortly and I had the plywood put up there before the siding went back on.
1. Use medium density close cell rather than icynene on the band joist in the basement.
1. Do a better job on the underside of the back bump out with a plywood enclosure. Probably won't get fixed.
1. Have more money, do it all at once when no one is living here.
1. Think more about how the transition at the chimney happens. There's a wee problem developing...

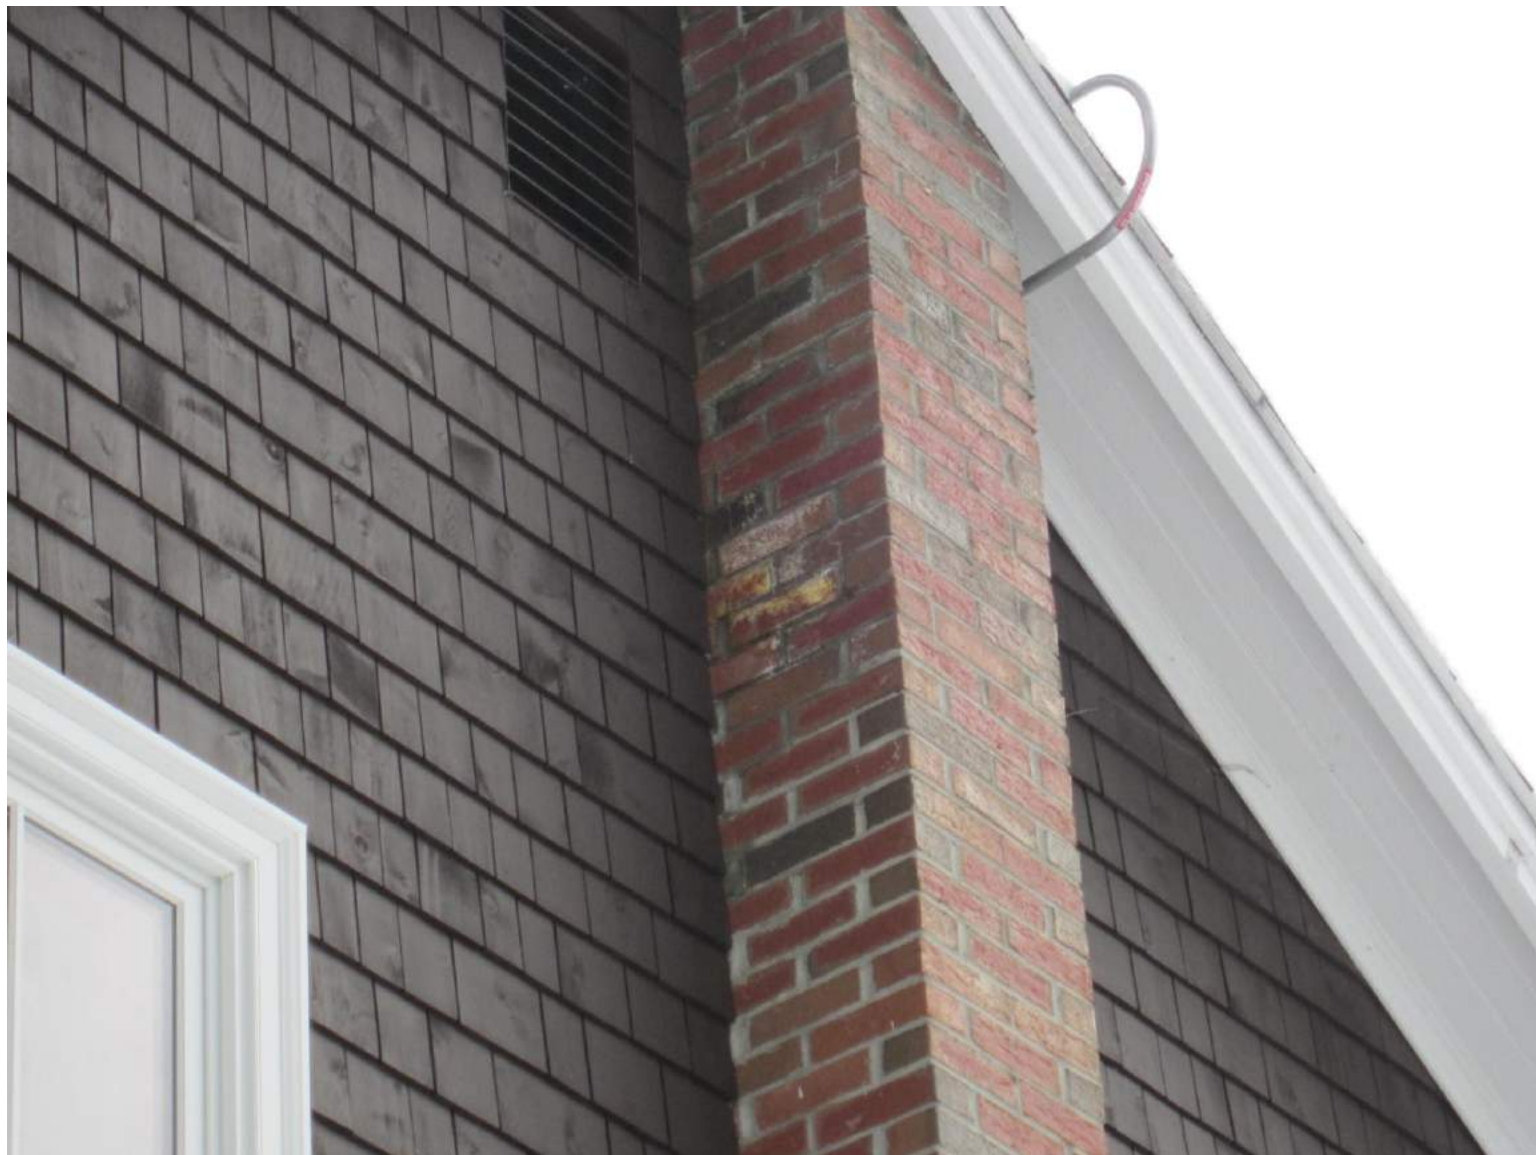
Chimney problem

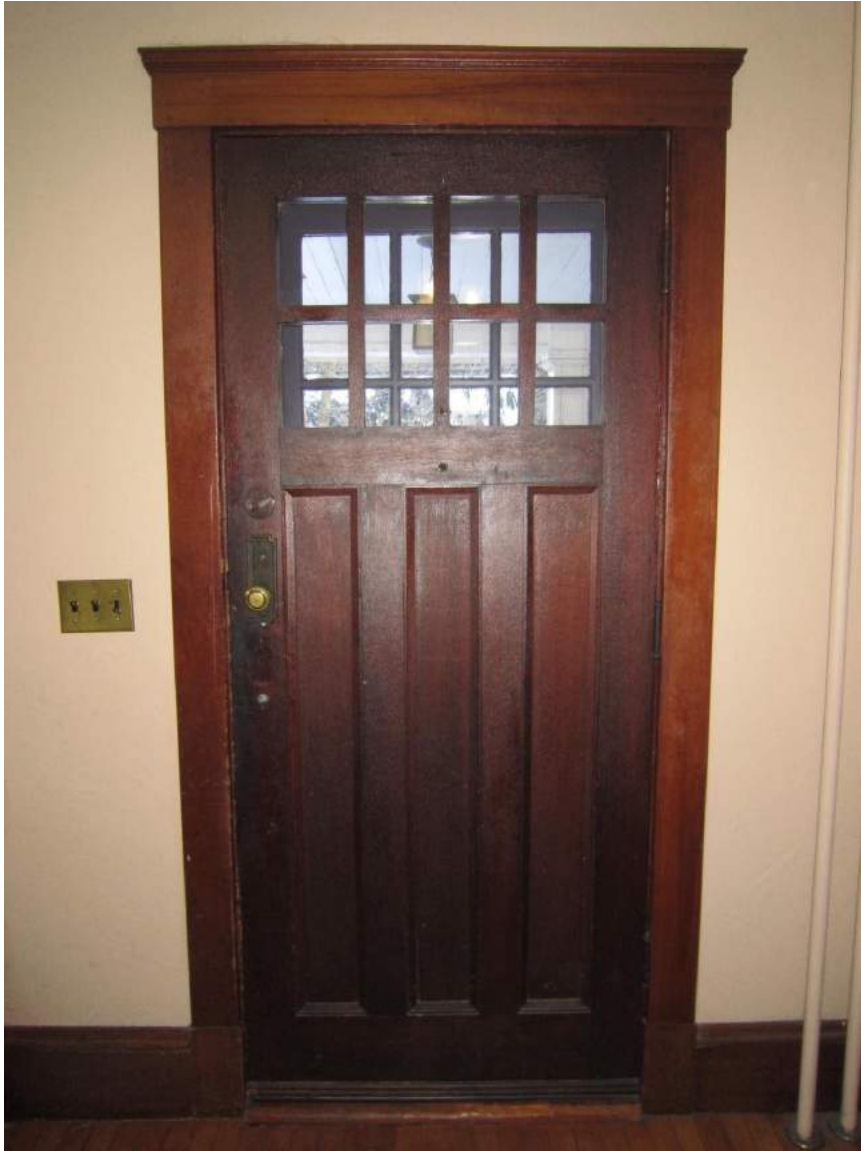
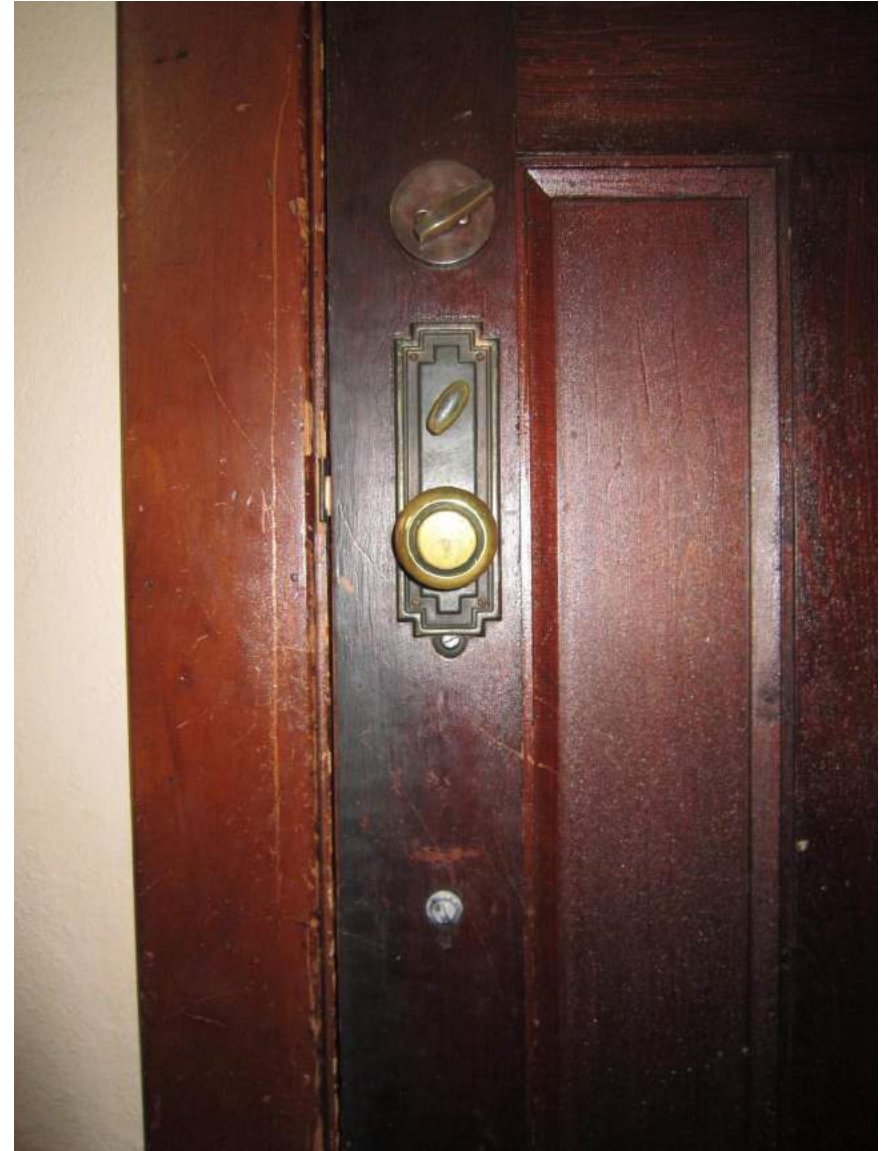
Thermal bridging at the front door- FROST-new storm needed
